TERRA 2012 | 12th SIACOT PROCEEDINGS

11th International Conference on the Study and Conservation
of Earthen Architectural Heritage

12th SIACOT Iberian-American Seminar on Earthen
Architecture and Construction

Edited by
Mariana Correia, Pamela Jerome
Marcial Bondet, Maddalena Achenza

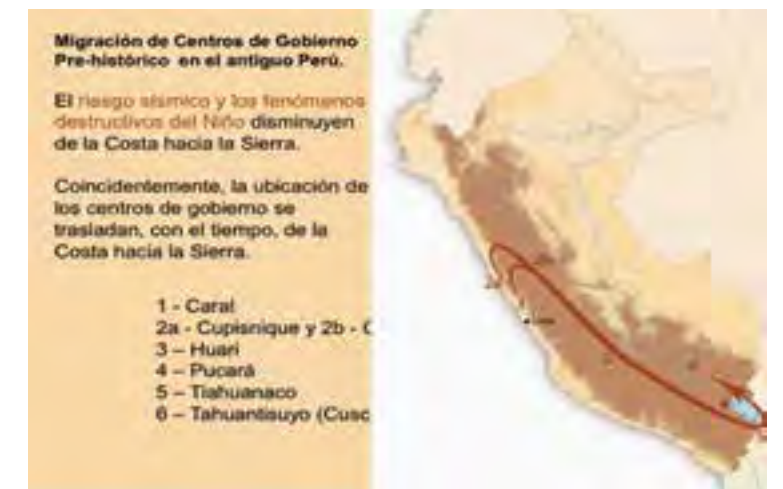
Fig.1 Migration of prehistoric government centers in Peru (credits: Julio Vargas-Neumann)

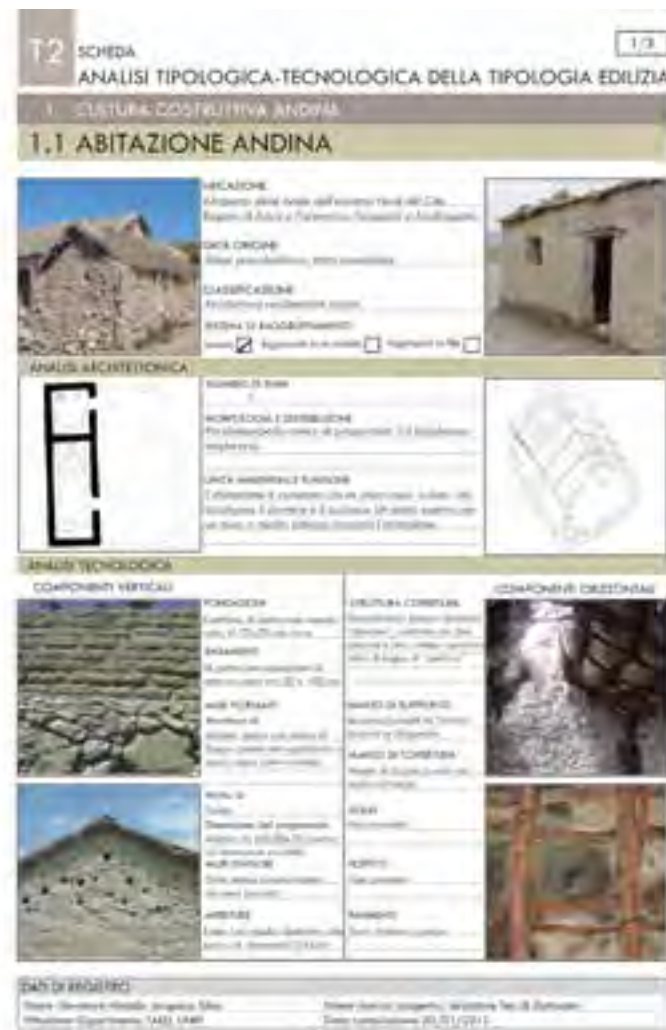
Fig.4 Example of the constructive-structural analysis factsheet of the Andean-type housing (credits: Natalia Jorquera, 2012)

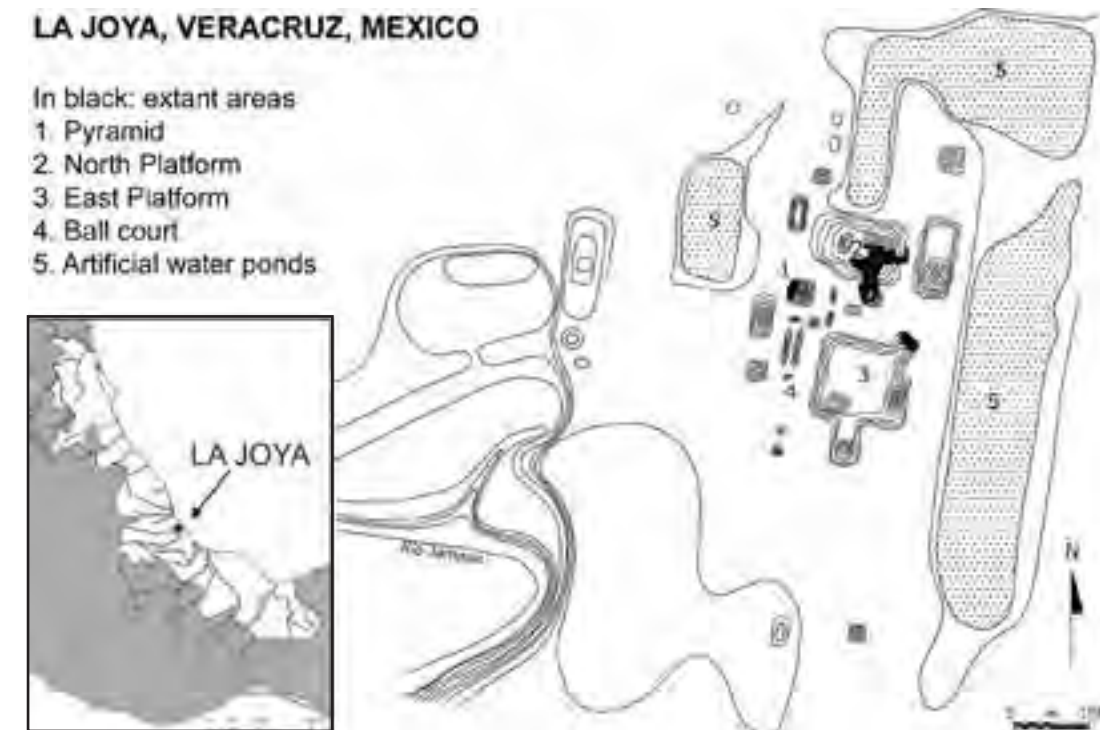
Fig.2 Map of La Joya, with central compound surrounded by a system of ponds. Inset: location of site within the State of Veracruz (credits: Annick Daneels)

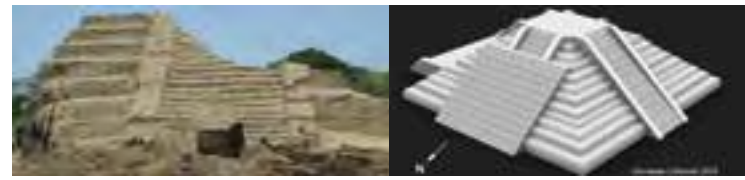
Fig.3 Above: pyramid's substructure west façade when excavated in May 2008. Below: reconstruction (credits: photo and excavation data by Annick Daneels, from project authorized by the Archaeology Council of Mexico's National Institute of Anthropology and History, 2008; hypothetical reconstruction by Giovanna Liberotti, 2010)

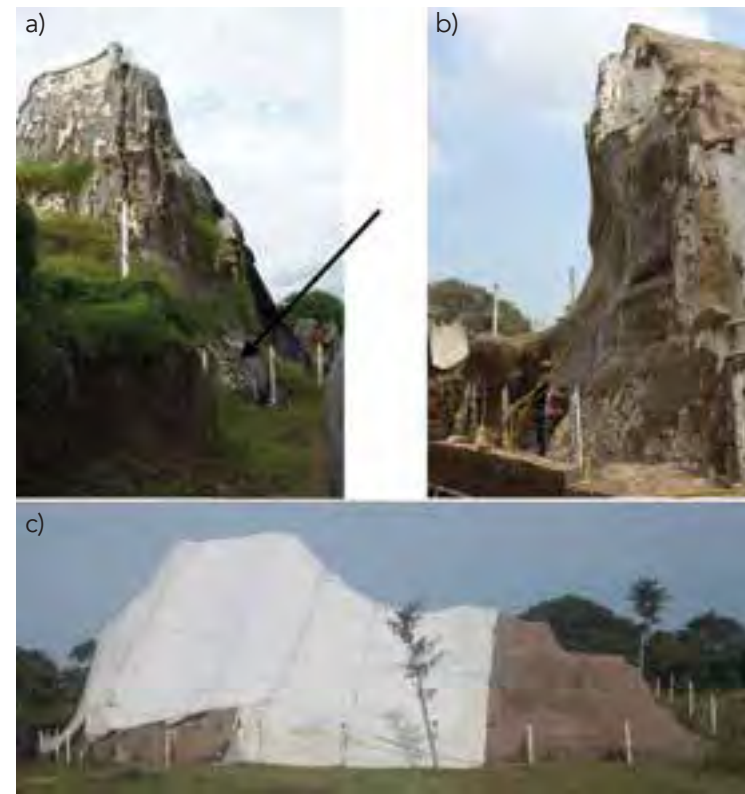
Fig.4 La Joya Pyramid in spring 2010: a. arrow indicates collapse of north retaining wall due to weeds, b. geotextile applied directly to north profile, c. west façade protected by tarpaulins, whereas for the southern sector (on the right) with the new sacrificial layer with vinyl polymer (credits: Annick Daneels, from project authorized by the Archaeology Council of Mexico's National Institute of Anthropology and History)

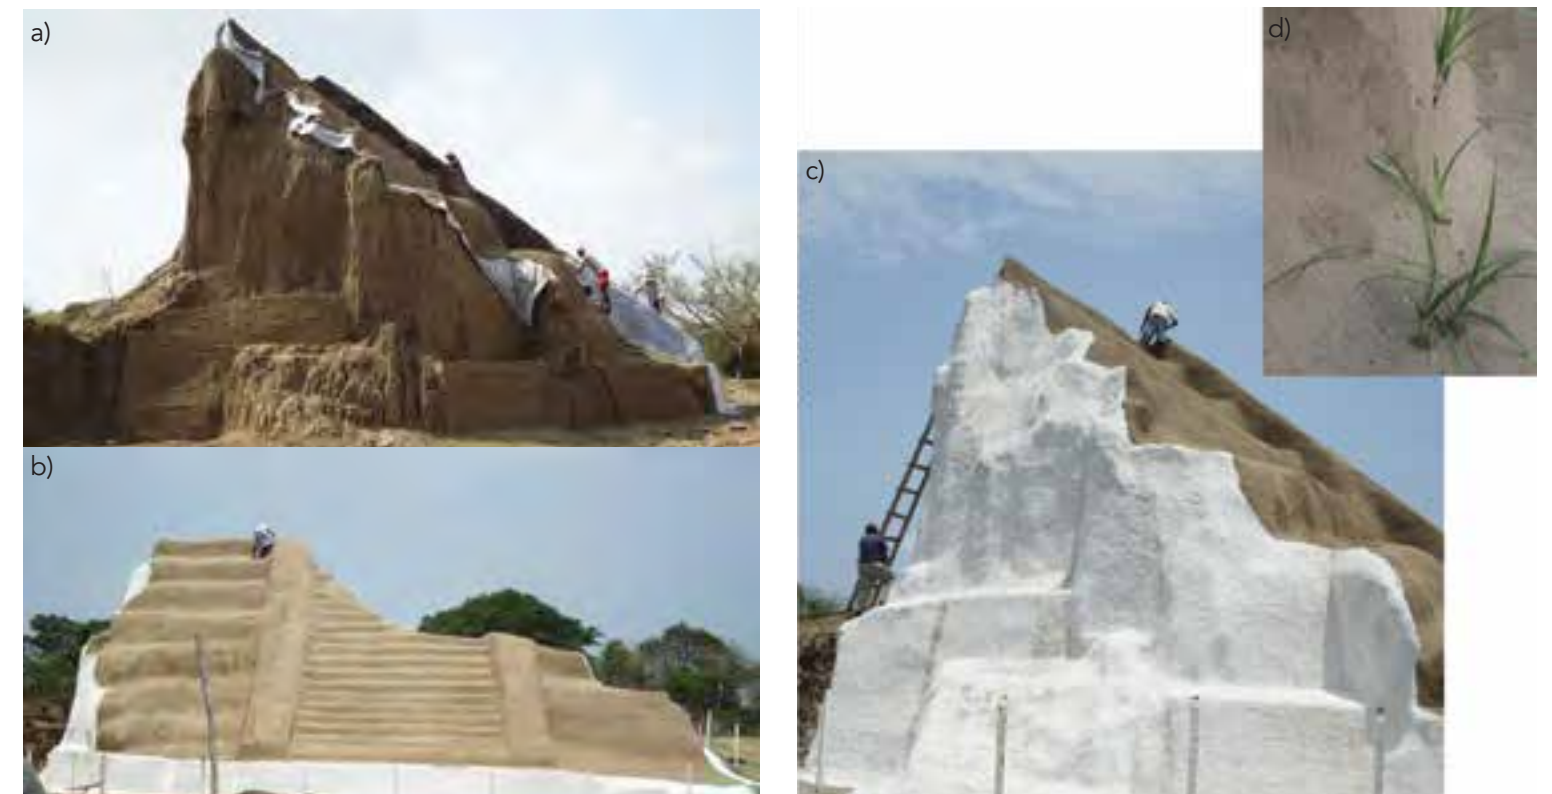
With bi-monthly control visits and photography, it was possible to systematically document that the summer rains of 2009 deteriorated the sacrificial layer, while the geotextile effectively protected the original structure, as the surface below remained firm. The retaining wall on the north profile collapsed because the weeds that started growing on the ledges percolated

Fig.5 La Joya Pyramid in spring 2009: first preservation experiment: a) retaining walls at the foot of west façade and on the north profile, placing of geotextile and protective layer; b) west façade after preservation; c) north profile after preservation and d) weeds growing through geotextile and sacrificial layer (credits: Annick Daneels, from project authorized by the Archaeology Council of Mexico's National Institute of Anthropology and History)

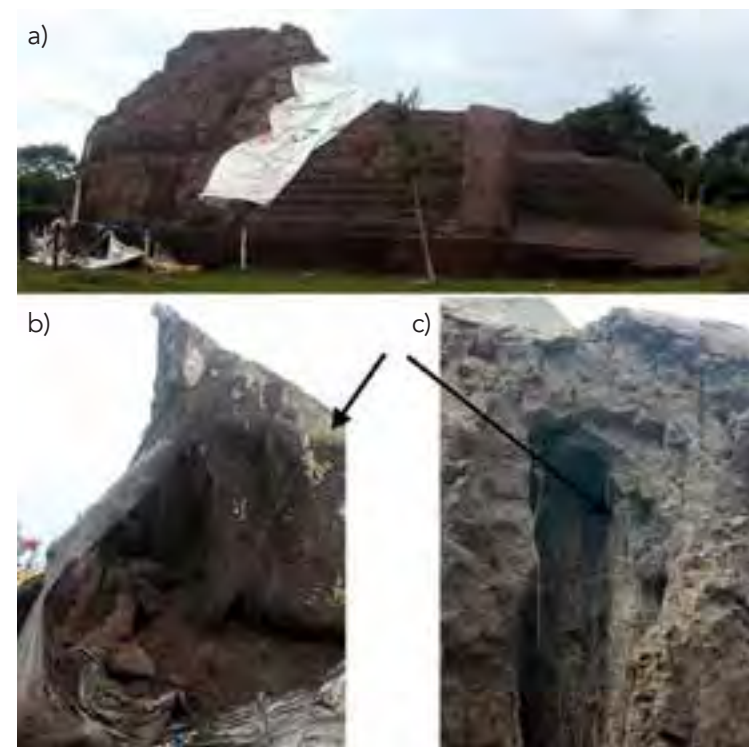
When removing the geotextile, it was possible to observe the presence of more than 1-m deep weed roots in the fracture zones, penetrating the original compacted-earth fill of the building and the modern sandy fill placed in 2009 as part of the raw brick retaining-wall system. The weeds did not grow on the façade itself, but on its northern edge, formerly exposed, where before preservation attempts, an invasion of a sturdy weed existed, identified as *Cyperus rotundus* L. of the Cyperaceae family. This weed has long rhizomes forming chains of bulbous tubers that developed below the geotextile, and cannot therefore be removed manually without damaging the textile, nor killed with standard glyphosate weed killers. It was first used FAENA forte (Monsanto) in 2009, then Finale Pro 15 (Bayer) in small experimental patches in 2010, at the recommendation of biologist Pablo Torres Soria, consulting specialist of the National Institute of Anthropology and History in Mexico in matters of site preservation. These applications were suspended in view of their inefficacy and the high toxicity of the products. This weed even broke through the polymer-consolidated sacrificial layer, showing that being cut off from sunlight does not affect its vitality. The presence of the roots suggests a repetition of the 2009 scenario: the weed catches the rain and allows it to penetrate along its roots beyond the geotextile, 1- to 2-m deep into

Fig.6 La Joya Pyramid in September 2010, after hurricane Karl: a. west façade with torn tarpaulins, southern sector (on the right) with polymer layer in good condition, b. collapse of north profile fill, arrows indicating weeds and roots, c. detail of weed roots in old crevices, originally filled with sand (credits: Annick Daneels, from project authorized by the Archaeology Council of Mexico's National Institute of Anthropology and History)

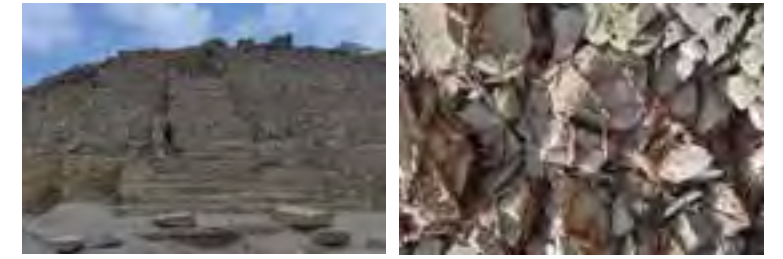
Fig.1 Staggered Pyramid "La Galería", in Caral, from 3,000 BC. The complex is built in stone masonry, earth mortar and wattle-and-daub (credits: Julio Vargas, 2011)

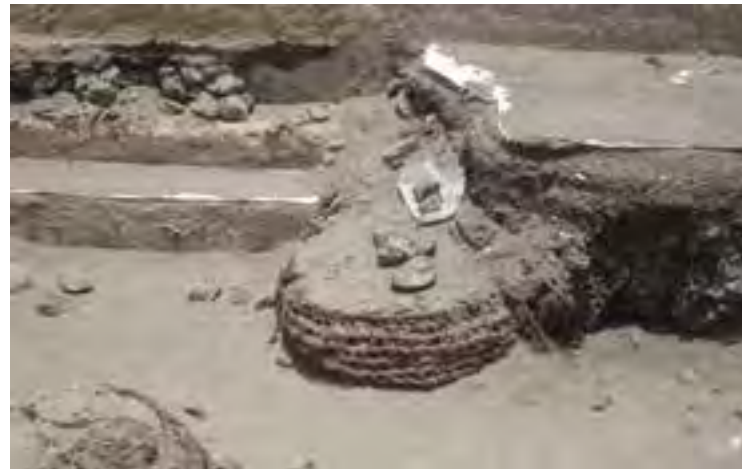
Fig.3 Remnants of shicras used for bagging stones for stable pyramids cores (credits: Julio Vargas, 2011)

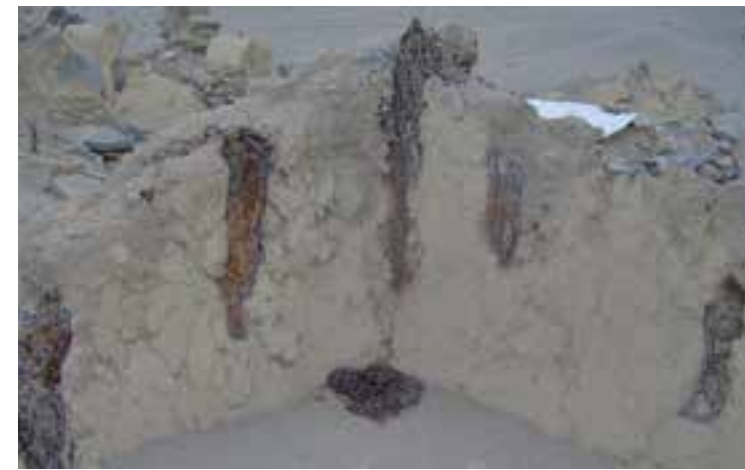
Fig.4 Quincha (wattle-and-daub) is an earthquake-resistant composite technology (credits: Julio Vargas, 2011)

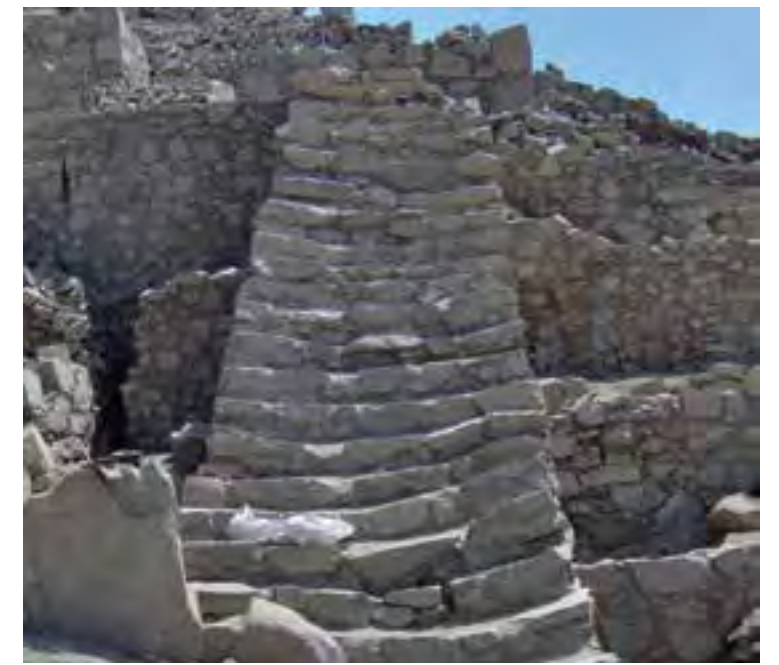
Fig.5 Unstable stairs requiring the renewal of shicras (credits: Julio Vargas, 2011)

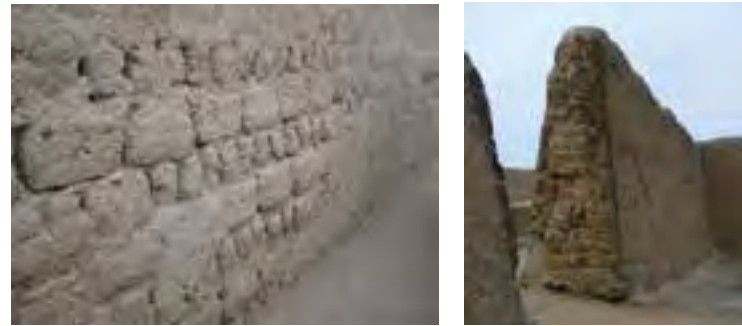
Fig.2 Different dimensions of adobes at Tschudi palace (credits: Mariana Correia, 2005)

Fig.3 Section of partially destroyed citadel wall (credits: Mariana Correia, 2005)

A high degree of control of the construction material and the building method can certainly be discerned related to adobe use in Chan Chan, with more than 17 different shapes of adobes identified at least for the complex walls (Campana, 2000, p. 117). For instance, a specific type of adobe with a truncated-pyramidal shape was applied for the citadels' surrounding walls. These walls had major relevance at the time and were built for defensive purposes. In the case of Tschudi Palace, the citadel wall has a height of 12 m and is 1,500-m long (Pinillos, 1995, p. 28). To ensure strong and thick earthen walls, the citadel's surrounding walls were built wider at their base and narrower at the top. With the increase of height, the wall thickness would decrease, as would the size of adobes. In this way, deterioration was avoided, due to "humidity and the salinity of the earth, and ensured that it [would be] earthquake-resistant" (Pinillos, 1995, p. 15).

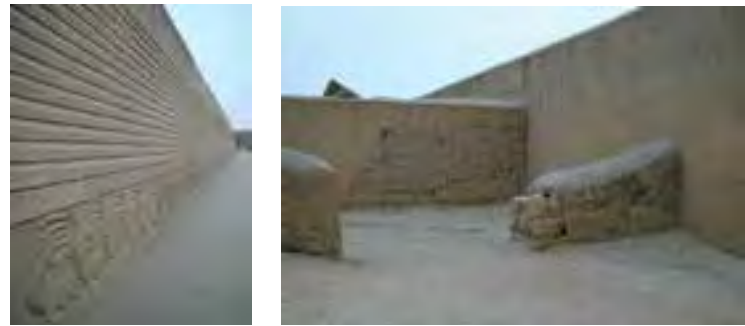
Fig.6 Grand Ceremonial Plaza with reconstructed walls during the 1960s, Tschudi palace, Chan Chan (credits: Mariana Correia, 2005)

Fig.7 The reconstruction of the surrounding wall done during the 1960s is identified on the exterior of Grand Ceremonial Plaza, Tschudi palace, Chan Chan (credits: Mariana Correia, 2005)

Chan Chan has had several conservation interventions in the last 50 years. Castellanos considers the existence of two conservation phases (2000, p. 71). The first phase was between 1964 and 1969 and relates to the Tschudi Palace intervention with a "type of highly criticized pastiche ... to satisfy the demands of mass tourism" (World Heritage, 2007, p. 8). Castellanos states that this was "largely oriented toward reconstruction for formal presentation" (2000, p. 71). The reconstruction of walls and frieze decorations can be observed in the Grand Ceremonial Plaza at the Tschudi Palace. Morales Gamarra supports the

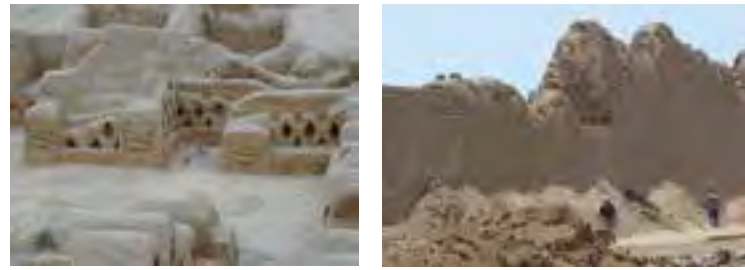
Fig.8 A sacrifice layer of gravel is used to protect the top of the walls. Audiences sector, Tschudi palace (credits: Mariana Correia, 2005)
Fig.9 Reconstruction of the surrounding wall in Velarde palace, Chan Chan (credits: Luis Guerrero, 2007)

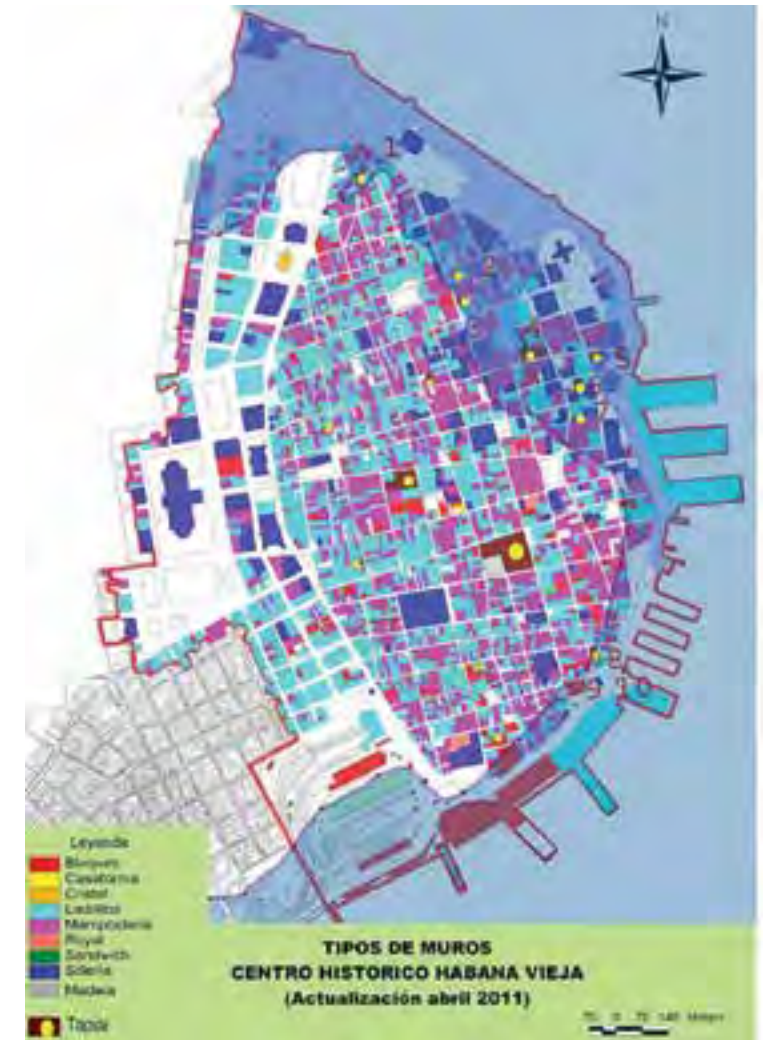
Fig.2 Inventory of wall types, and primary and secondary flooded areas in Old Havana; yellow circles reveal rammed-earth construction (credits: Rodriguez, 2011 - Plan Maestro de la oficina del Historiador de la Ciudad de la Habana, Dirección de Planificación Física Ciudad Habana y CITMA Ciudad Habana, 2006-2011)

The critical flood zone (primary) coincides with the low areas near the initial development part of the city, close to the mouth of the channel that provided access to the bay. The wharfs of the first port are also included in this area. This zone represents very valuable urban fabric in its architectural, historical and heritage components. The outline of this primary urban sector provides an approximation of the original line coast.

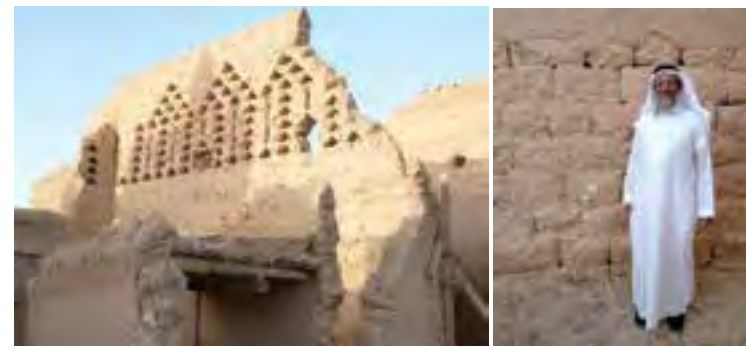
Fig.2 A wide variety of historic Najdi architecture is found on the site (credits: Pamela Jerome, 2011)

Fig.3 One of the authors standing next to a high stone foundation for scale. These provide traditional flood protection for the mud-brick superstructures (credits: Pamela Jerome, 2011)

The traditional architecture was designed to withstand the effects of floods by having tall stone foundations. However, the capacity of the recently installed plumbing infrastructure needs to be able to accommodate extreme events, including 100-year floods. In addition, provisional measures may be required, such as temporary backfilling in advance of the 'rainy' season, typically the spring and fall on the Arabian plateau. In general, backfilling of excavation soundings will both clarify presentation and prevent destruction by ponded water.

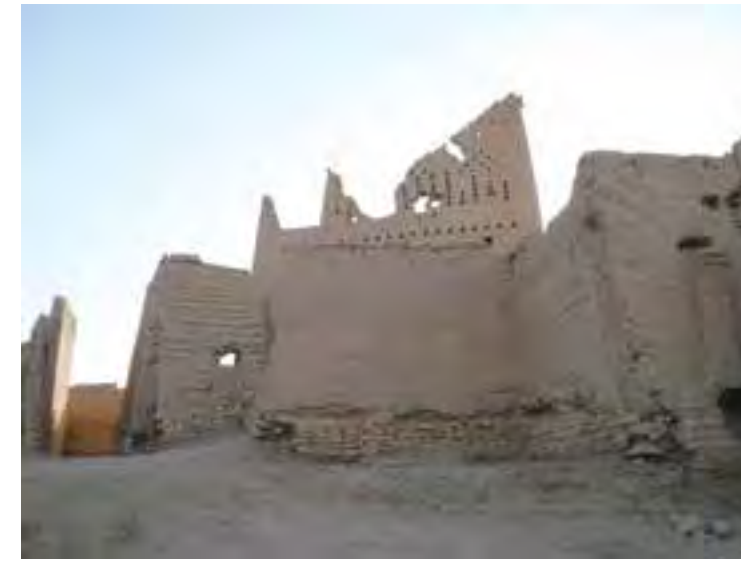
Fig.4 Textures vary at the site and are an important aesthetic that should be protected (credits: Pamela Jerome, 2011)

- Appreciate and document the principal qualities of the historic architecture and archaeology by recognizing the subtle textural languages of the structures on site. During the workshop's inspection, at least four types of earthen construction were noted, and no less than four general styles

and textures of plaster finishes; these possibly represent and reflect the period at which a structure was first built. It is important to guard against the use of unified styles of plastering, color and texture. A unified pattern of color and texture will lead to a bland and monotonous appearance. Therefore, each wall, internal and external, of each structure should adopt a texture and color unique to the historic finishes observed in situ.

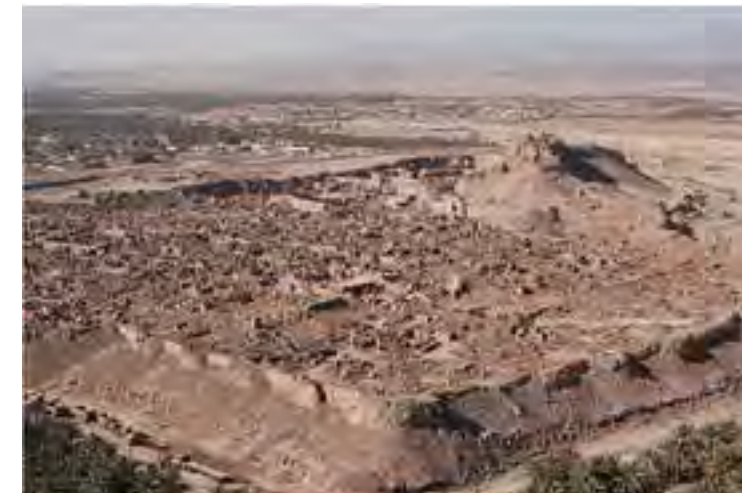
Fig.1 The Bam citadel in 2004 after the 2003 earthquake (credits: RPBCH, 2011)

At first assessment, the earthquake damage was estimated to be well over 80%. The Bam citadel appeared to be a mass of ruins; however, subsequent analyses and surveys, revealed otherwise. These surveys were based on the comparison of the volume of the earthen structures before and after the earthquake. For example, the volume of the standing outer-boundary wall of the citadel before the earthquake was 168,570 cubic meters. This volume decreased to 151,319 cubic meters after the earthquake. Thus, the volume of destruction was

17,250 cubic meters, or in other words, 10.33% of the wall. This can also be calculated holistically based on the volume of the entire citadel as a complex (the boundary wall, the important buildings described in the pilot projects, government's quarter and residential areas). In this case, around 195,935 cubic meters were destroyed; this amounts to about 23.7% of the entire volume of the buildings (Keramatfar, 2008).

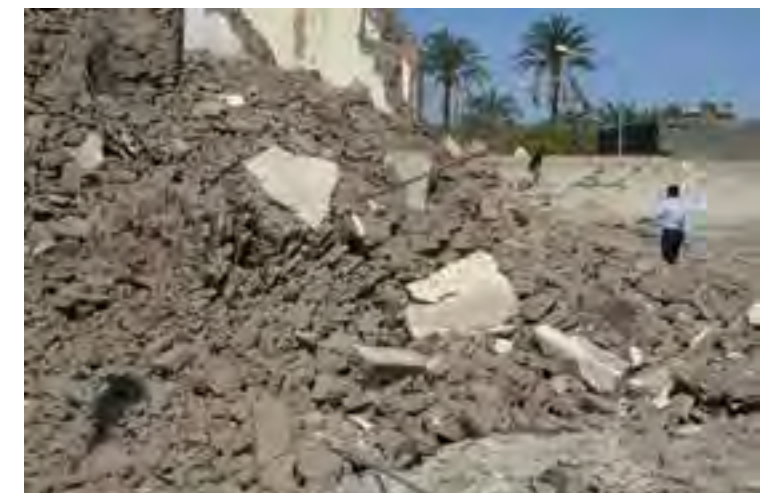
Fig.2 The city of Bam after the earthquake (credits: G. Amirjamshidi, 2004)

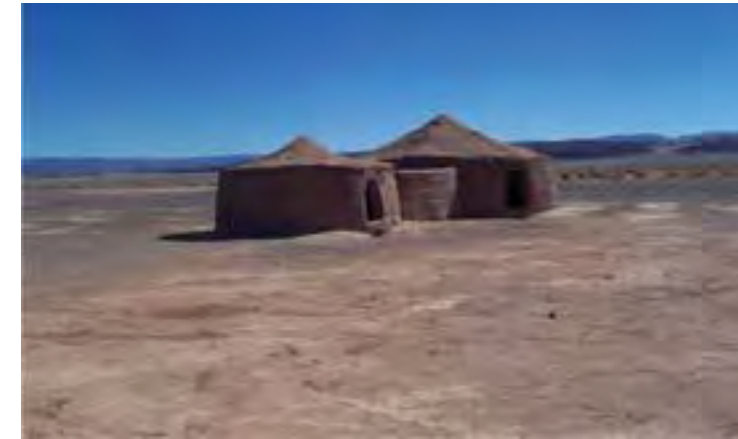
Fig.2 Replicas of two village dwellings built as a conservation practice site (credits: Monica Bahamondez)

In the first assessment visits, this phenomenon was evident as it was possible to observe the effect of erosion on different structures, which were well documented. Even structures built on the test grounds showed severe damage to their bases as a result of erosion by the winds. From the foregoing, it was concluded that it was necessary to stabilize the top of the walls that had been irreversibly degraded by designing 'capping' solutions (Morales, 1983; Muñoz and Bahamondez, 1990; 1992-1993; 1993)

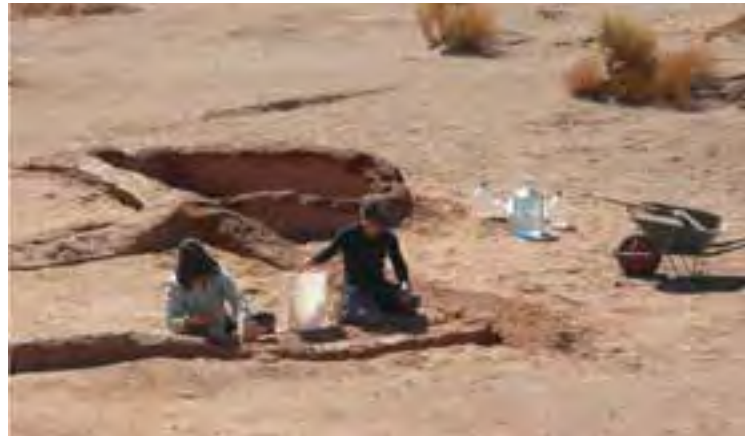
Fig.3 Removal of salt-contaminated first coating layer. (credits: Monica Bahamondez)

After removing the unsound material from the tops, the walls were cleaned and the sound parts were stabilized; this was followed by a gradual wetting process in preparation for 'capping'. As mentioned above, this "capping" material in a wet and plastic condition is different from that of the original tops of the walls. The "capping" mixture was prepared by the combination and adjustment of the right proportions of sand, earth and water, taking into consideration the differential behavior in unlike parts of the tops of the walls by the range of types and amount of salts in their structure.

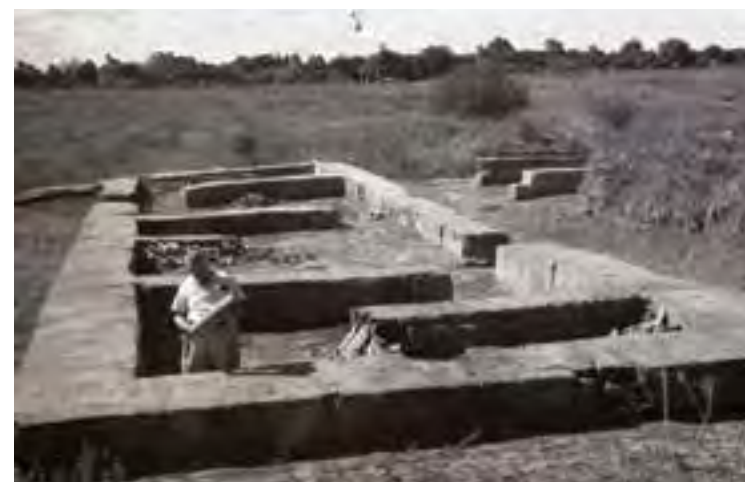
Fig.2 Archaeologist Agustín Zapata Gollan with the remains of rammed earth walls of a house he excavated (credits: Ethnographic Museum in Santa Fe, near 1952)

All archaeological structures are constructed of ordinary rammed earth. Although the French pisé was also used, no evidence of such construction was recovered, possibly because of the methods used during the archaeological excavations.

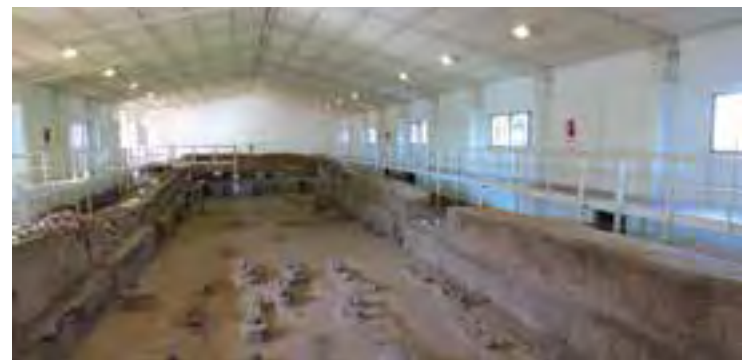
Fig.3 Protective shelter for the church of San Francisco built in 1973 (credits: Luis Maria Calvo, 2005)

- These structures have effectively protected the rammed earth remains. Three decades after Rodríguez Camilloni formulated

this assessment, it is recognized that the wall structures have survived in reasonably good condition.

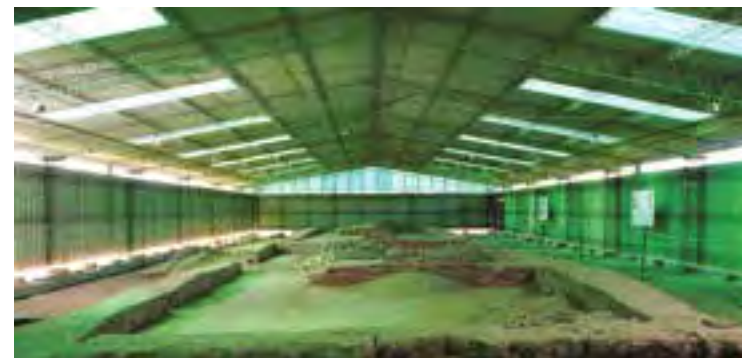
Fig.4 Protection of the Gonzalez de Ataide house according to the prototype designed by H. Rodriguez Camilloni (credits: Jorge Anichini, 2005)

prototype (Rodriguez Camilloni, 1987, p.9), whose proposed design consisted on:

The purpose of these structures is to nullify the main causes of deterioration (wind action and rain erosion), to control the access of visitors, and in turn to allow a museographical display. For two decades the Conservation Plan was the guideline for all actions that were undertaken at Santa Fe La Vieja. In the 1990s, six protective structures were built following the prototype designed by Rodriguez Camilloni, one for the Council and five for the houses (González de Ataide, Fernandez Montiel, Paez, Cifuentes and Garay).

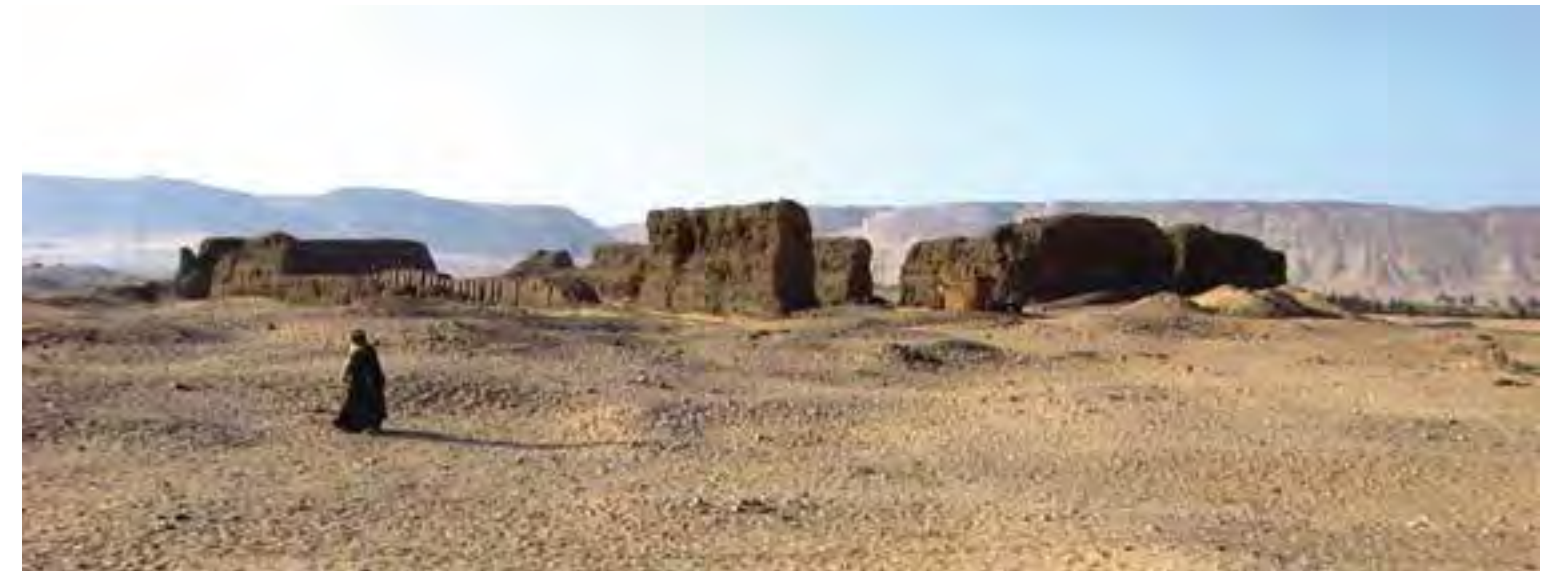
Fig.1 Shunet el Zabib, the funerary enclosure of Khasekhemwy from the north, with mud brick walls 11 meter high (credits: Anthony Crosby, 2001)

The large mud-brick enclosure at north Abydos known today as the Shunet el Zebib was built near the end of the 2nd Dynasty (ca. 2750 BCE) to serve as a cultic enclosure for King Khasekhemwy, last king of the dynasty. It represents half of a two-part funerary complex, the other consisting of his underground tomb, located some 1.5 km to the south of the enclosure at a part of the site known as Umm el-Qa'ab. The enclosure was the last and largest of a series of royal cult enclosures at Abydos that, insofar as presently available evidence indicates, begins at the start of the 1st Dynasty, corresponding to a dramatic increase in scale in royal tomb construction at Umm el-Qa'ab. All the kings of the 1st Dynasty, as well as the last two of the 2nd, were entombed at Abydos, and it appears that each also built a corresponding enclosure. Given that the royal tombs

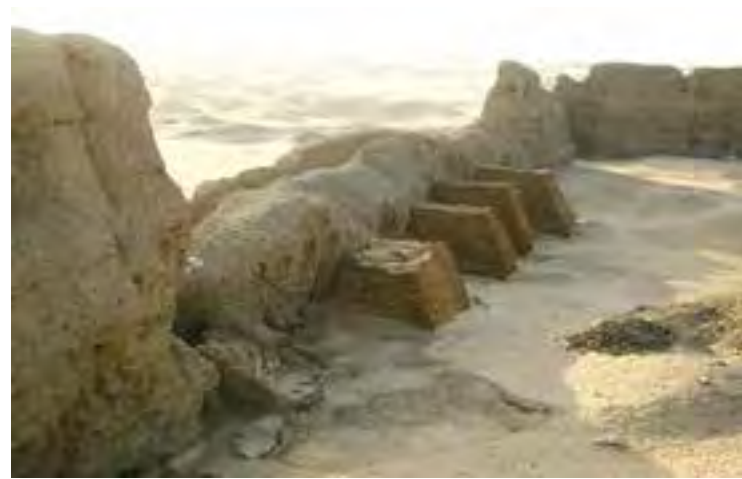
Fig.2 Large sandbag buttresses were constructed in 2001 to support the east enclosure wall (credits: Anthony Crosby, 2006)

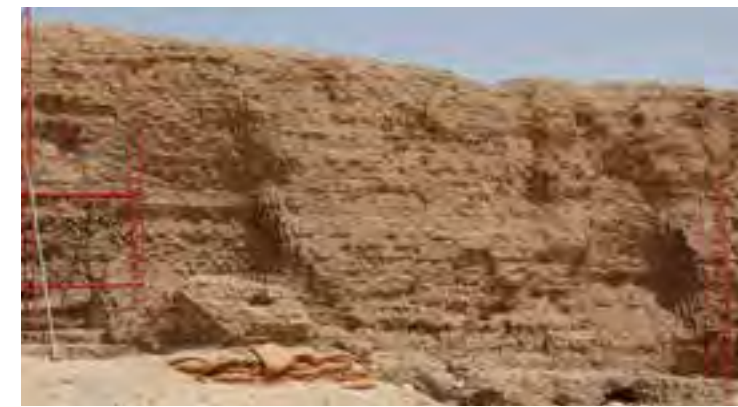
Fig.3 The west enclosure wall showing the completion of the stabilization of two collapsed areas where Coptic cells existed (credits: Anthony Crosby, 2006)

The large collapsed areas were partially reconstructed with mud bricks following the same coursing as the original. The reconstruction of a collapsed Coptic cell was not completed flush to the existing wall, but recessed to indicate that a cultural feature existed. Geogrid was used as horizontal reinforcement at the approximate same vertical spacing as the original reed mats.

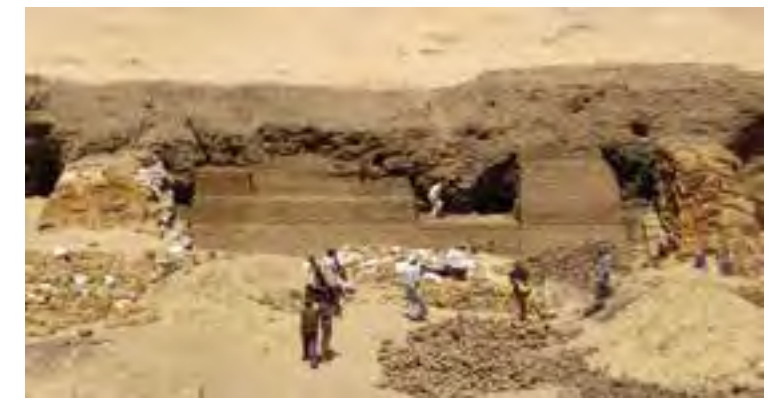
Fig.4 East enclosure wall showing the process of constructing the mud-brick foundation system (credits: Anthony Crosby, 2010)

The most severe conditions of unsupported upper walls has resulted from the construction of the Coptic cells and their eventual collapse and the loss of foundation sand from the east enclosure wall from mid-19th-century archeological excavations. These conditions have required the greater interventions in the form of replacing much of the loss materials from the Coptic-cell collapse and the construction of a mud-brick foundation system along the interior of the east enclosure wall.

Mid 19th century excavations extended along the east wall were approximately 3 meters deep – they were never backfilled. Sand began to move from under the wall into the trench, and the lower mud bricks followed the sand into the excavation trench. A new foundation is being constructed to provide the missing support for the east wall. It extends out from the original wall plane approximately 1 meter and extends 1 meter below the original base of the wall. The new sections are completed between the sandbag buttresses, and once completed, the buttresses are removed and the two sections are connected with a continuation of the foundation.

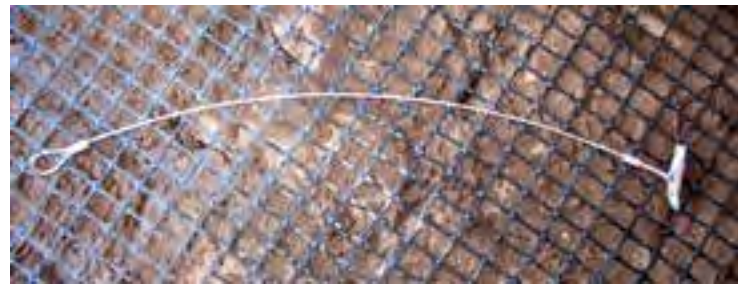
Fig.5 Aluminum wedges attached to stainless-steel cables used to attach geogrid to mud brick walls (credits: Anthony Crosby, 2010)

The new mechanical ties are similar, but much simpler in design and installation. They consist of aluminum wedges attached to stainless-steel cables. Holes are drilled and the aluminum wedges are driven into the historic mud bricks. Tension is put on the cables and the aluminum wedges are set perpendicular to the axis of the drilled holes, locking them in place. The cables are then attached to the geogrid.

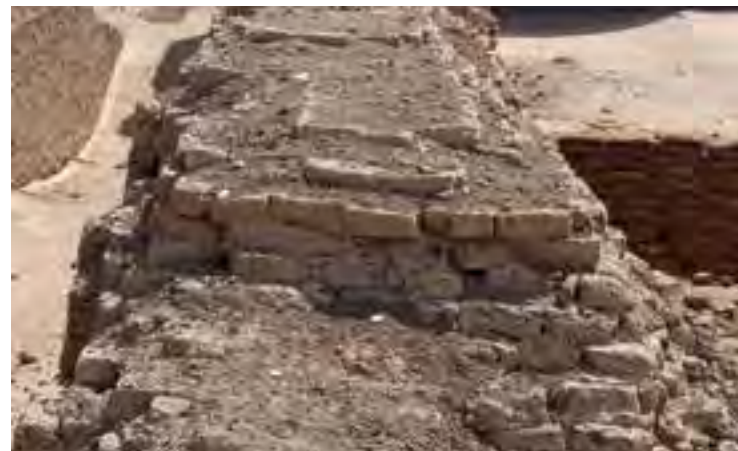
Fig.6 Comparison of mud-brick protective cap and existing wall top (credits: Anthony Crosby, 2005)

It is estimated that the tops of the walls, unaffected by more traumatic loss, have eroded approximately 3 meters, vertically, over the 4,700-year life of the structure. The upper most exposed mud bricks are friable and will continue to erode, albeit, extremely slowly, because of the lack of significant rainfall. While a lower priority than the reconstruction of missing structural elements, capping using unstabilized mud bricks is one of the important treatment interventions. The tops of the walls are prepared by removing loose, friable materials and new mud bricks are placed in the general contours of the existing walls. The contouring of the cap and the distribution of additional loose soil result in a character that evokes the character of the pre-treated wall tops.

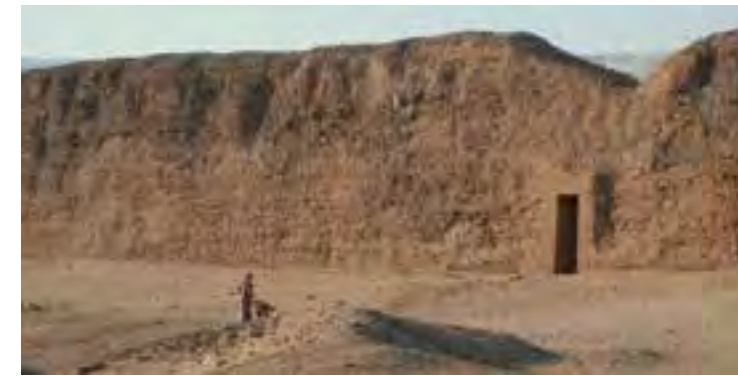
Fig.7 The west enclosure wall from the north after completion of the west gateway stabilization and restoration (credits: Anthony Crosby, 2010)

The important structural stabilization of the walls at the original gateways into the Shuneh presented an important presentation issue. The missing mud-brick sections had to be rebuilt to support failing end walls and the decision was made to include an opening into the Shuneh through the new masonry. After much deliberation a decision to partially restore the west gateway to its historic appearance was made. The existing footprint of the gate was known from archeological evidence and additional research to determine the appropriate height and other details was undertaken. The results from the combination of research and physical evidence is a gate opening approximately 3 meters high with exposed beams and lintels; the proportions are based on the royal cubit. The wall surfaces immediately adjacent to the opening are restored to their original plane, but immediately blend to the color, texture and wall planes of the existing mud-brick masonry of the Shuneh.

of the conservation treatments. In addition, the presentation solutions have been developed and incorporated into the conservation specifications with the completion of the partial restoration of the west gate. In future seasons, the work will continue with the stabilization of the remaining tall walls, the filling of voids and the stabilization of the other gateways. Eventually, all of the walls will be capped with a sacrificial layer of mud bricks. The sacrificial bricks will ultimately erode, but in the meantime the original bricks beneath will be protected.

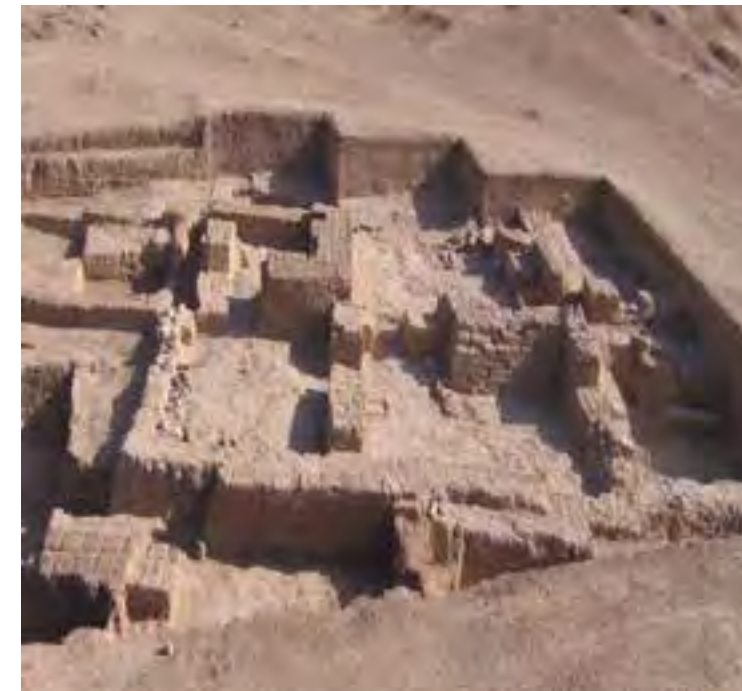
Fig.2 Tell Beydar: adobe and rammed-earth walls in Field C (credits: Ricardo Cabral, 2010)

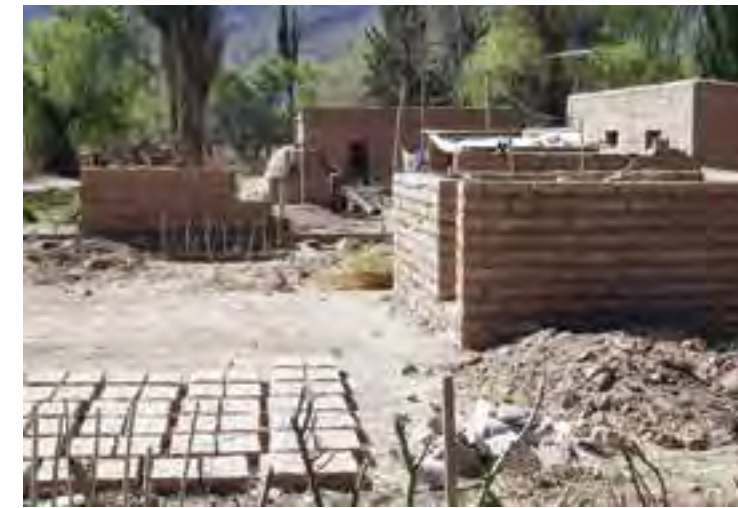
Fig.1 Self-construction of a domestic housing using adobe, and terracotta tiles on hollow reed in El Perchel, Argentina (credits: Rodolfo Rotondaro, 2009)

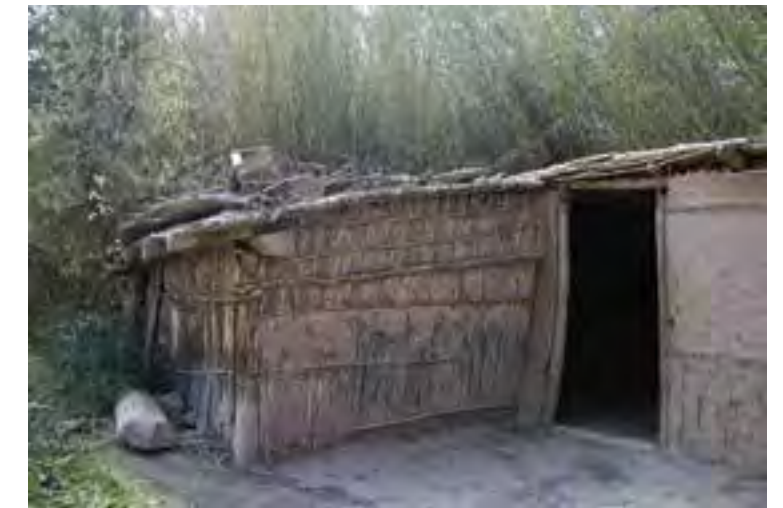
Fig.2 Quincha depot in an agricultural sugar plantation near Route 9, close to Maimará, Argentina (credits: Rodolfo Rotondaro, 2009)

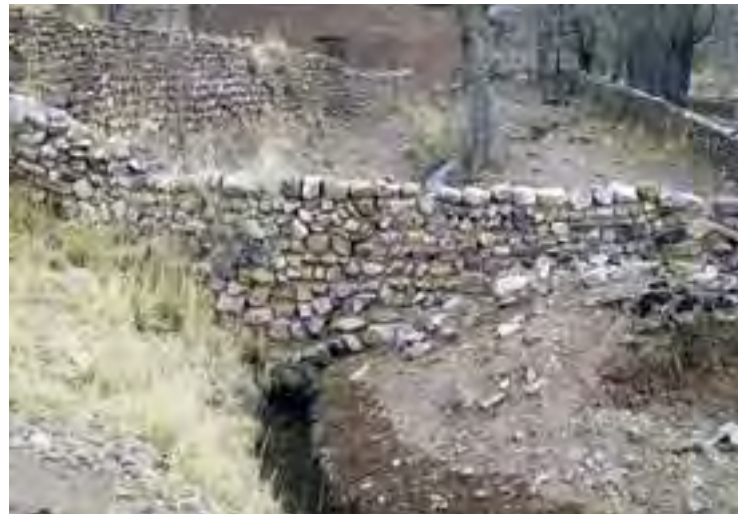
Fig.3 House fence of stone and clay over an irrigation ditch outside Iturbe, Argentina (credits: Rofolfo Rotondaro, 2009)

The use of local materials and autochthonous techniques is also observed, in a clear and effective way, in the boundaries of domestic, agricultural or grazing areas. The fences are built with stacked stones; blocks cut from the floor or *champas* (grass); stones and earthen mortar; adobe masonry; rammed-earth; stone, clay and adobe; and different variants according to the practices of the self-builder.

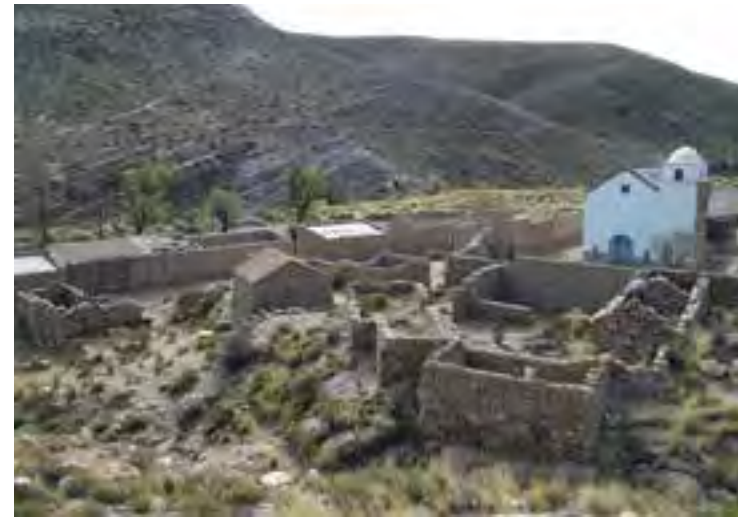
Fig.4 Hamlet and small church in La Cueva, Argentina, constructed of adobe, stone and clay, earthen plasters, and terracotta tiles roof (credits: Rodolfo Rotondaro, 2009)

The configurations of small settlements and rural villages are adapted to the topography and are mostly built with local materials – mainly adobe, terracotta tiles, clay, stone and wood from the area. Almost all settlements include small chapels and churches, also predominantly built with local materials. In regards to churches, the influence of shapes, patterns and spatial organization of building elements are notably of colonial origin, imitating the most important churches in the urban centers of the Quebrada.

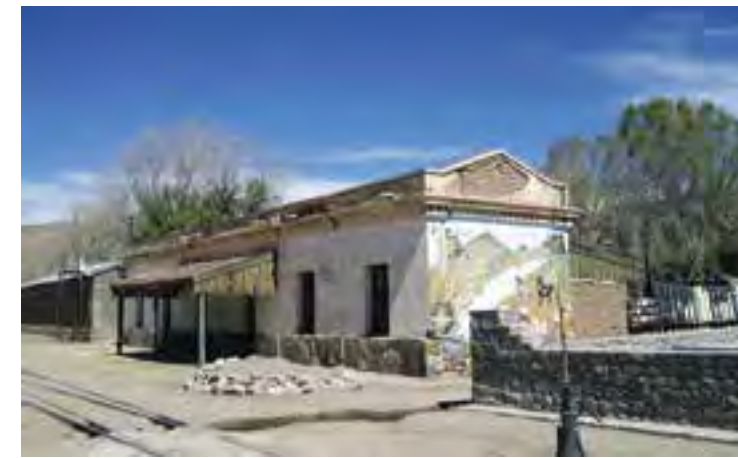
Fig.5 Housing for railway staff of Tres Cruces railway station, in Argentina (credits: Mónica Ferrari, 2009)

The railway that joined the provincial capital, S. S. Jujuy, with the city of La Quiaca was built between 1906 and 1908, and was characterized by more than 20 houses built entirely or partially of adobe walls. Regarding the latter, and according to up-to-date railway plans, these were built of stone at the foundation, and adobe-masonry walls, such as the ones at the Yala railway station; or adobe and fired brick, as is the case at

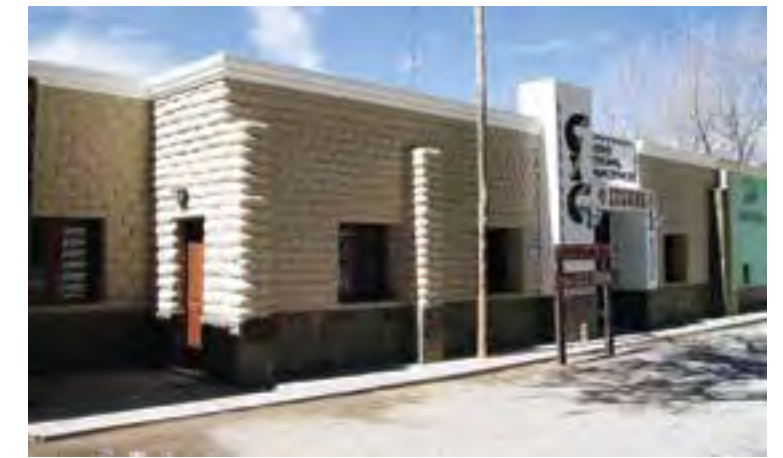
Fig.6 Cultural Community Center with plastered adobe walls in Iturbe in the northeast of the Quebrada, Argentina (credits: Rodolfo Rotondaro, 2009)

additions depend on local efforts (e.g. Huachichocana); micro-regional and effective community halls; and cultural centers of regional relevance (such as the child cultural center of Tantanakuy in Humahuaca). The technology used varies from the local native use of adobe walls with earthen plaster and lime paint, and terracotta tiles on woven reed or timber; up to other innovations, such as the use of soil-cement and soil-lime, Trombe wall, square adobe, interior reinforcement with reeds; and stabilized earthen plasters; etc.

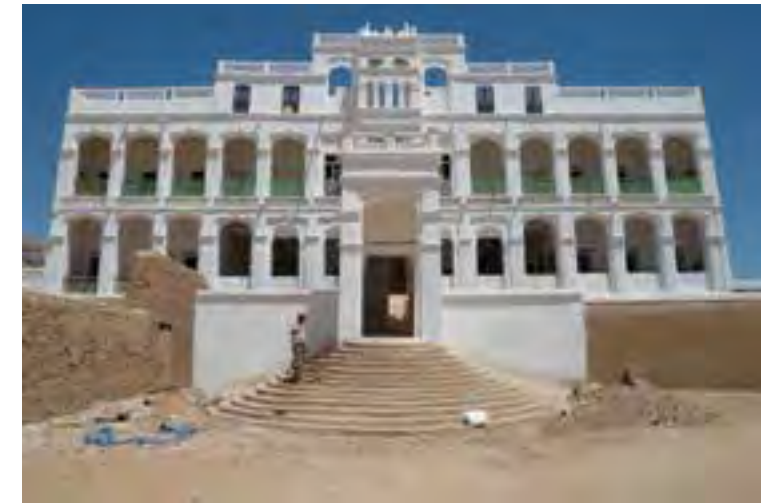
Fig.1 The Hamtut after restoration of the exterior (credits: Pamela Jerome, 2010)

third contract (al-Fijr and Qasr Abd al-Rahman Bin Sheikh al-Kaf). Work on the Hamtut, involving structural repairs to foundations, replacement of rotted beams and lime-plaster waterproofing of roofs (2), was completed between January and March 2010. Repairs to al-Riyadh were similar in nature, and were accomplished from October 2010 through January 2011. For al-'Ishshah, a large complex of structures constructed over a minimum of four phases, maintenance involved the conservation of the rear elevations of the structures along the north side, including the north façade of the main palace, east gate, Dar Dawil, kitchen wing, and pigeonnaire/well structure, as the south, east and west façades of the main palace had already been restored with funding from the Ministry of Culture. The work commenced in February 2011 and was completed in June of the same year. The repairs to al-Fijr and Qasr Abd al-Rahman Bin Sheikh al Kaf are scheduled to commence in September 2011. The latter suffered partial collapse of its main façade only two weeks after TMPP completed recording the building. Temporary shoring was installed in February 2007 following a GTZ-sponsored training workshop. The intent in this case is to use PCF money rebuild the corner, thus reinstating its monumental Neo-Classical façade.
