TERRA 2012 | 12th SIACOT PROCEEDINGS

11th International Conference on the Study and Conservation
of Earthen Architectural Heritage

12th SIACOT Iberian-American Seminar on Earthen
Architecture and Construction

Edited by
Mariana Correia, Pamela Jerome
Marcial Bondet, Maddalena Achenza

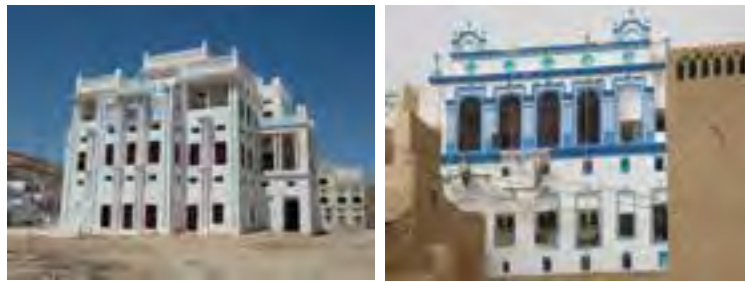
Fig.2 Al-Riyadh following restoration of the exterior (credits: Pamela Jerome, 2010)

Fig.3 Work in progress on the north elevation of the main building of al-'Ishshah Palace (credits: Mohammad al-Junied, 2011)

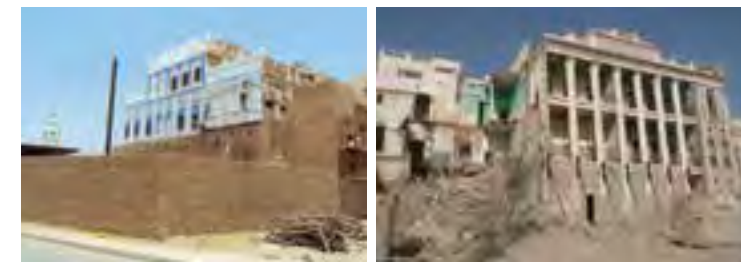
Fig.4 Dar Dawil, the oldest building in al-'Ishshah complex, during restoration (credits: Mohammad al-Junied, 2011)

Fig.5 Qasr Abd al-Rahman Bin Sheikh al-Kaf in its current state with the collapsed southwest corner stabilized by a GTZ workshop in February 2007 (credits: Pamela Jerome, 2007)

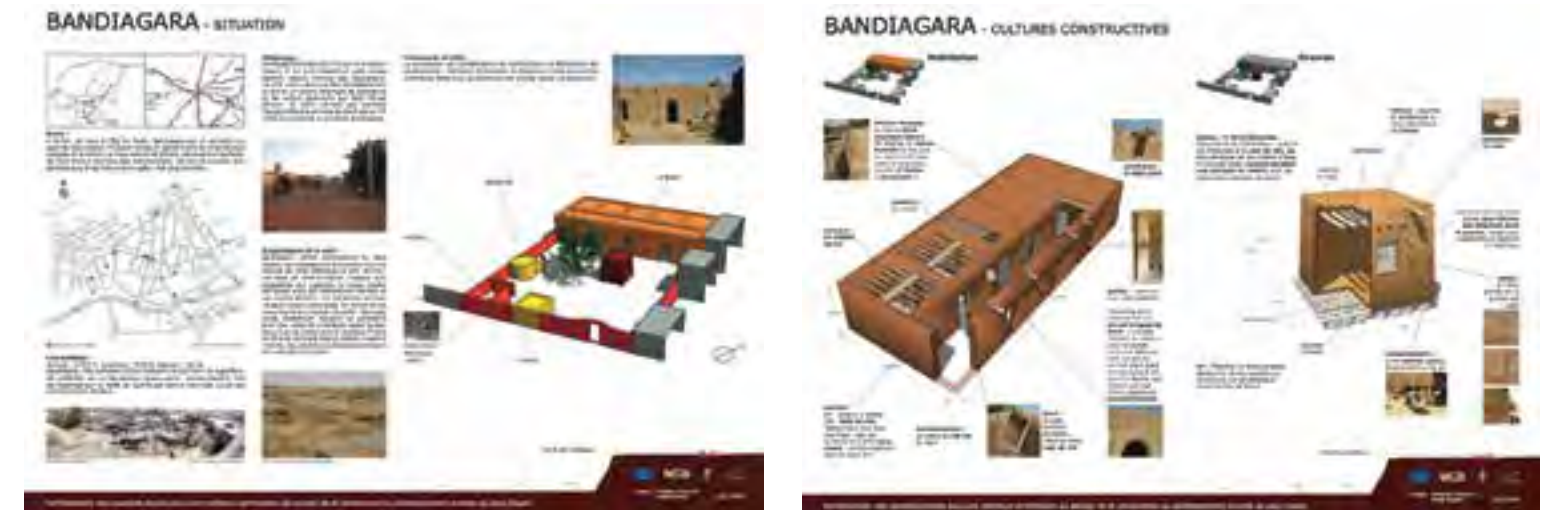
Fig.2 Left: Analysis of urban fabric in Bandiagara and traditional organization of a house plot. Right: Description of the house building parts (credits: CRAterre, Mathilde Chamodot, Basile Cloquet, 2008)

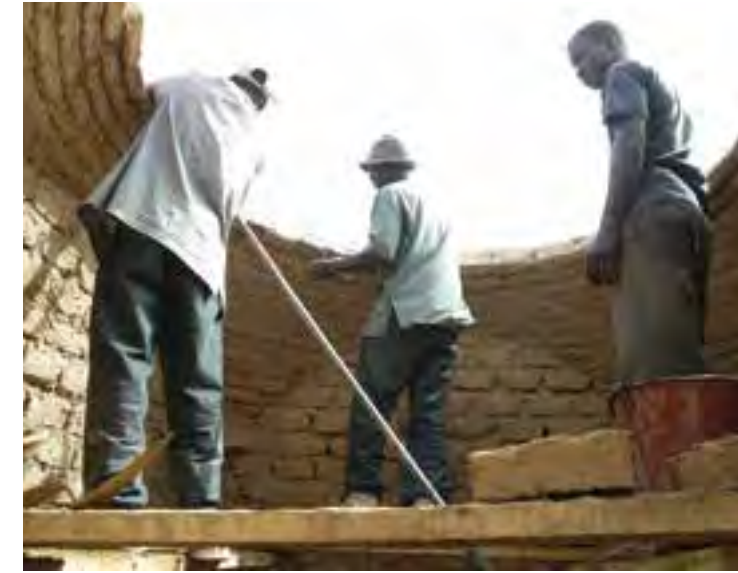
Fig.4 Construction of cupolas (credits: CRAterre, Laure Cornet, 2010)

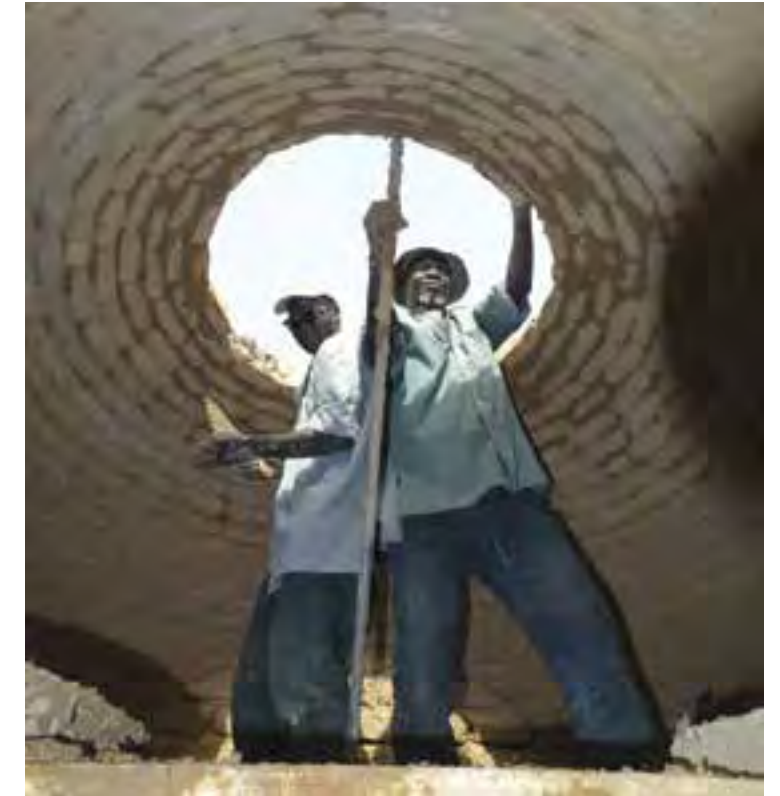
Fig.5 Construction of cupolas (credits: CRAterre, Laure Cornet, 2010)

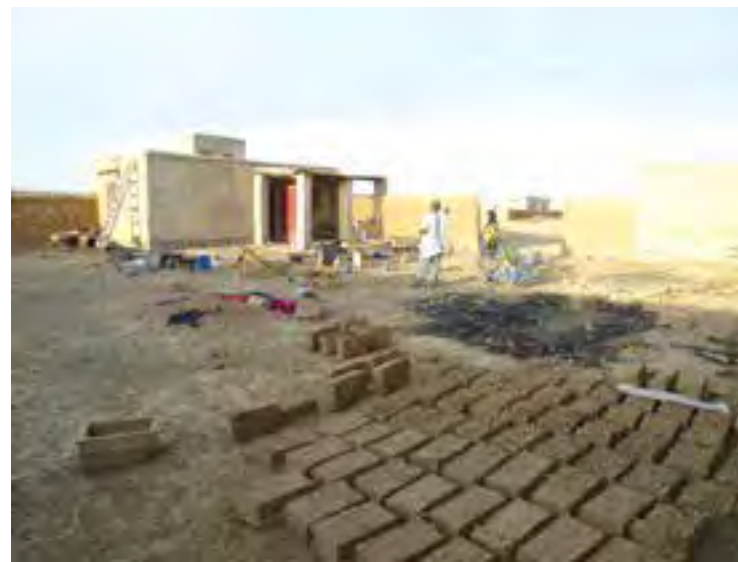
Fig.6 Adobes ready for the recovery (credits: CRAterre, Thierry Joffroy, 2011)

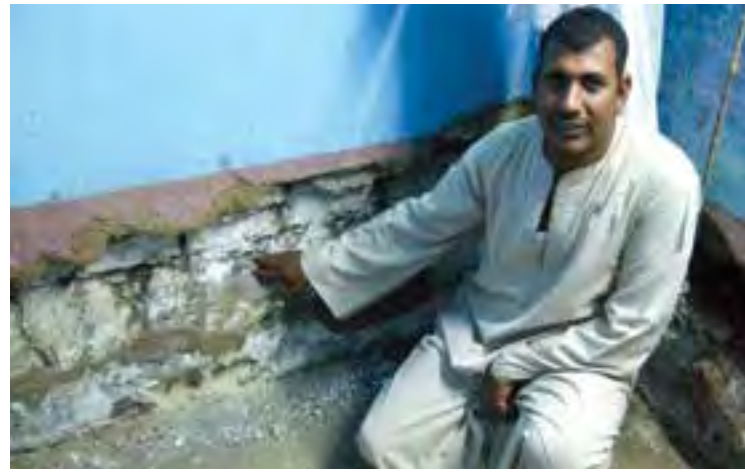
Fig.1 New Gournia Resident showing effects of rising damp (credits: World Monuments Fund/Community Consortium, 2010)

These groundwater conditions increase the capillary rise of moisture and salt migration, contributing to the disaggregation of limestone within foundations and the de-cohesion of mud bricks. In walls, this results in significant basal erosion, destroying the outer wythes of earthen bricks. The lower courses show efflorescence, and the failure of the physicochemical matrix forms deepening concave features at the wall base. The degradation compromises structural integrity, thereby reducing the load-bearing capacity of foundations and lower story walls.

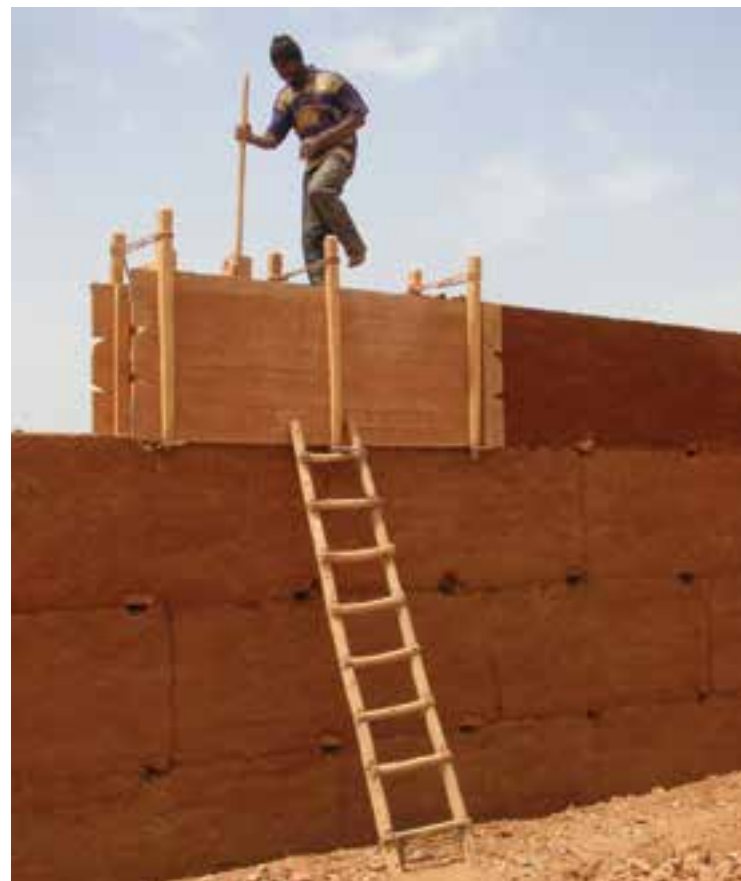
Fig.4 Rammed-earth masonry construction in the Drâa Valley (credits: Saverio Mecca, 2007)

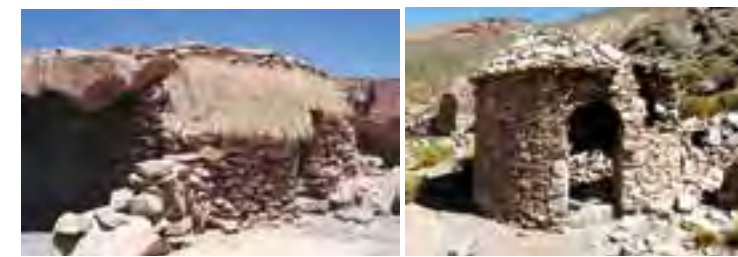
Fig.2 One *puesto* built with *pirca seca* (credits: Jorge Tomasí)

Fig.3 A case of a circular kitchen in a rural house, with a false vault in stone (credits: Jorge Tomasí)

It is common to build a stone-plinth foundation with up to 1 m in height and 30 to 40 cm in width made with earthen mortar. These plinths aim to improve not only settlement, but also protect the adobe wall from the possible rising damp, and the backsplash and runoff of rainwater (Schilman and Reisner, 2011). *Estancias* and other specific types of constructions, such as *fuegueros* (open spaces for cooking) or farmyards, and even today it is common to find walls built that are built in *pirca seca*, a type of crude wall construction of dry-laid unshaped stones without using mortar.

Although the use of stone today, in general terms, is limited to the foundations, the oldest buildings show that it was usual that all the walls were raised using this material. Stone construction was involved even in the execution of false vault ceilings. The descriptions from the early 20th century are consistent with these observations. In fact, Eduardo Holmberg, who toured Puna in 1900, referring to the characteristics of the houses, noted that "*the walls are always of stone, some also being observed of adobe, the roofs use Puna pasture, and are supported by crossbeams or tie-rods of cardón*" (a giant cactus species) (1988, p. 74-75). Throughout the 20th century, it is possible to notice a change, mostly from the mid-20th century on, in the role of stone as a building material. This is noticed by a continuous growth in the use of adobe up to today. In some cases, it becomes the exclusive material used when building a house. On the one hand, the construction of adobe walls is faster and more accessible to less skilled builders. On the other hand, the increased availability of vehicles to carry the adobes to country houses has allowed overcoming the problem of the lack of sufficient water to produce the adobes in many places.

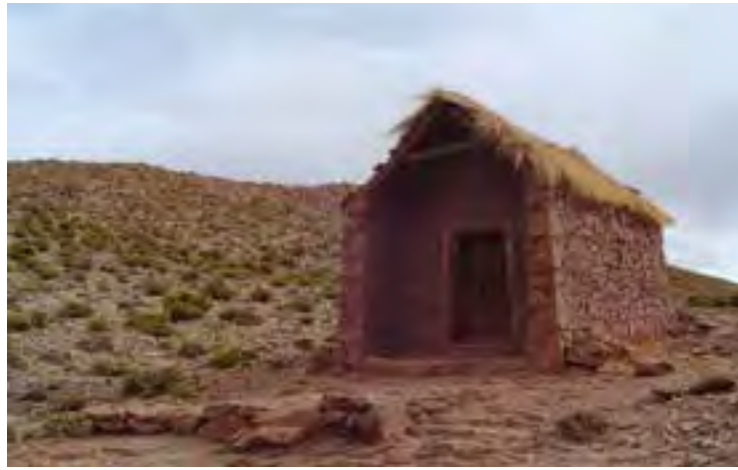
Fig.4 Domestic church (oratorio) with the guayado technique (credits: Jorge Tomasi)

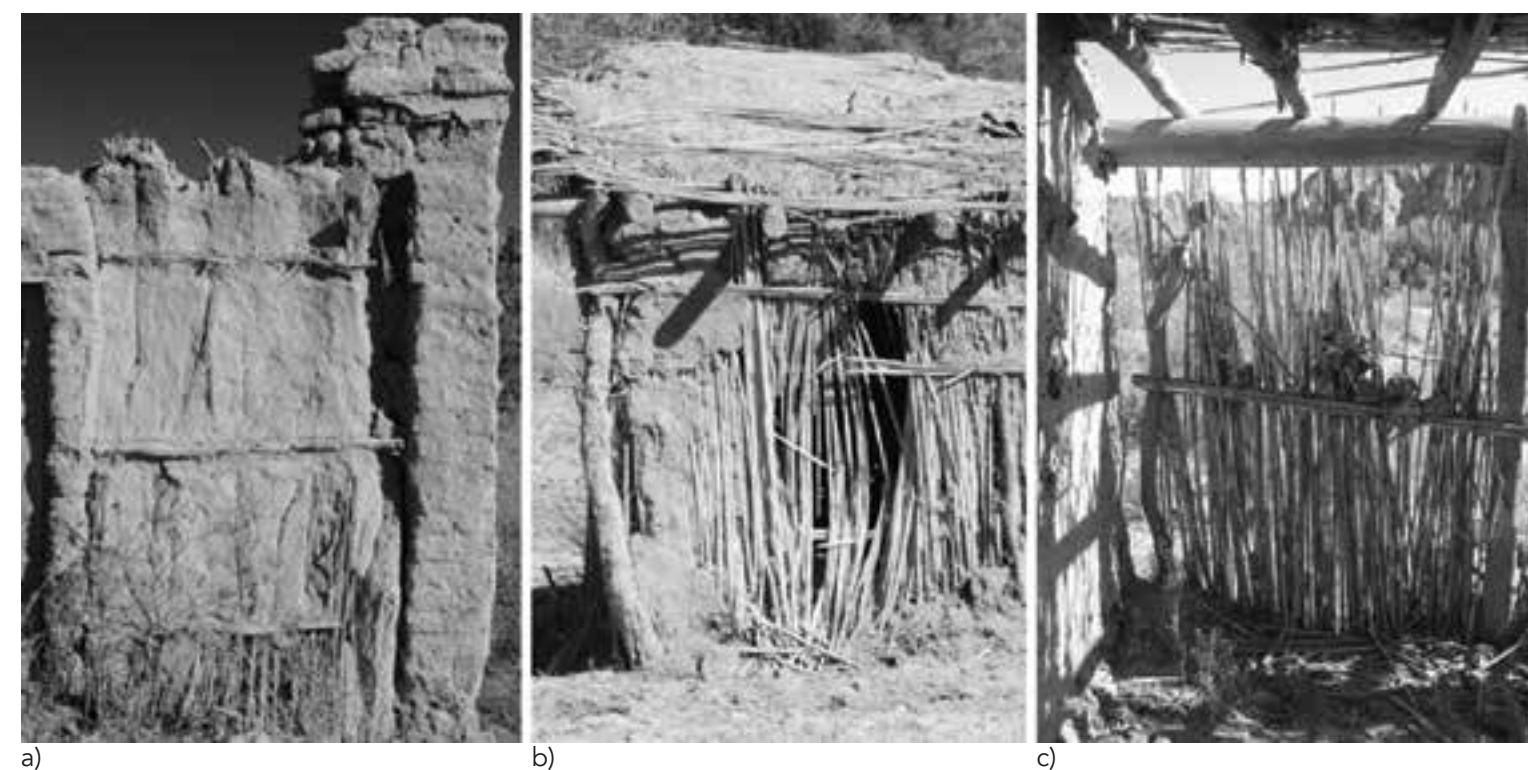
Fig.2 Quincha walls with Castile cane and carob lattice (credits: Guillermo Rolón, 2011)

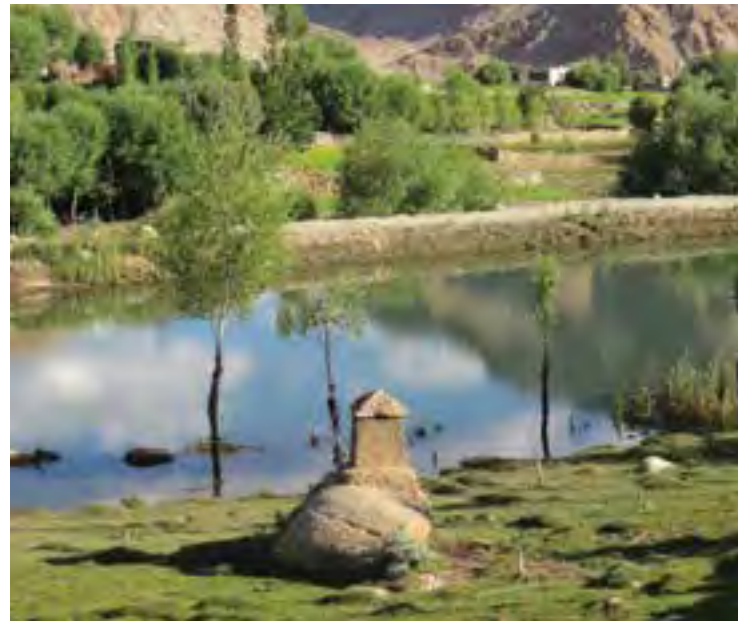
Fig.3 A lubang built over a boulder near the village pond, Chemday (credits: Tara Sharma, 2012)

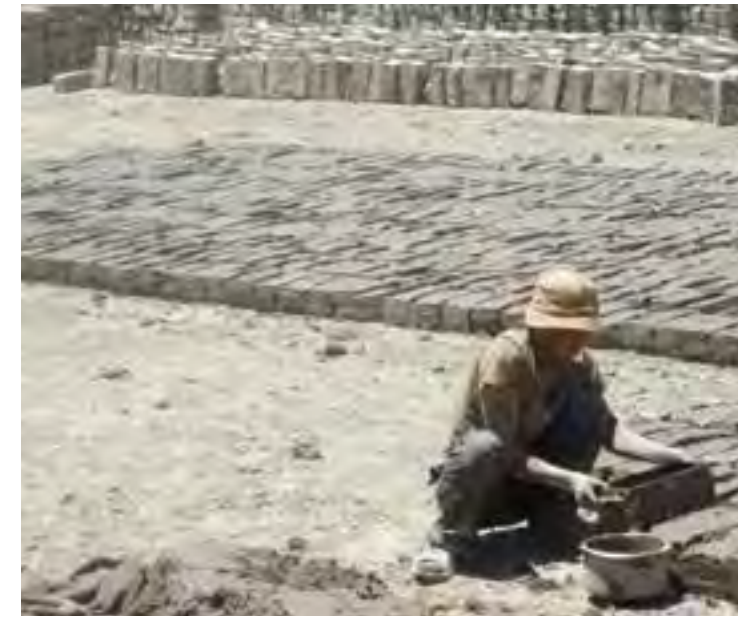
Fig.4 Contemporary production of mud bricks in the village of Shey (credits: Tara Sharma, 2011)

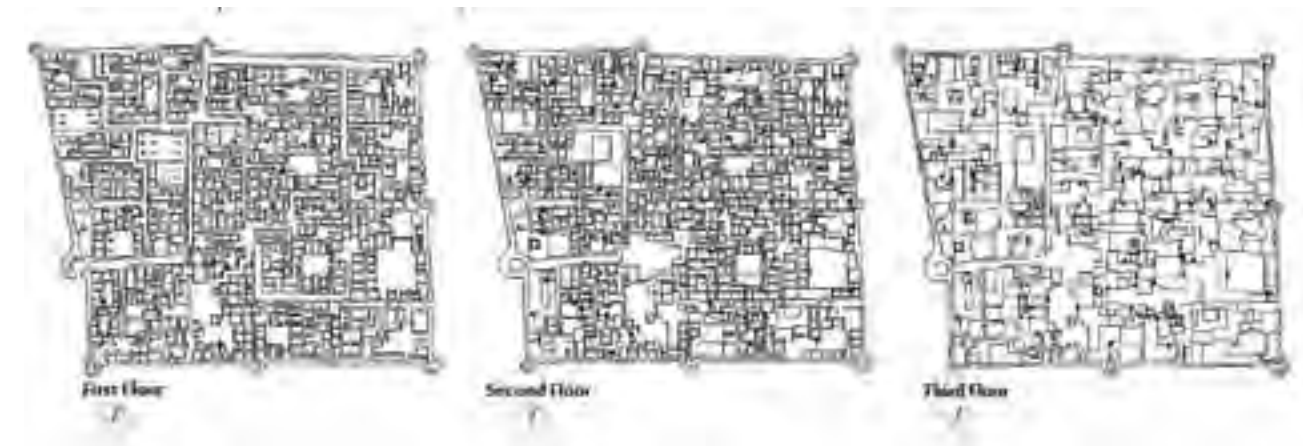
Fig.1 Floor plans of the historic site of Moorcheh Khort (credits: Renovation Company for Moorcheh Khort Historical Fortress, 2008)

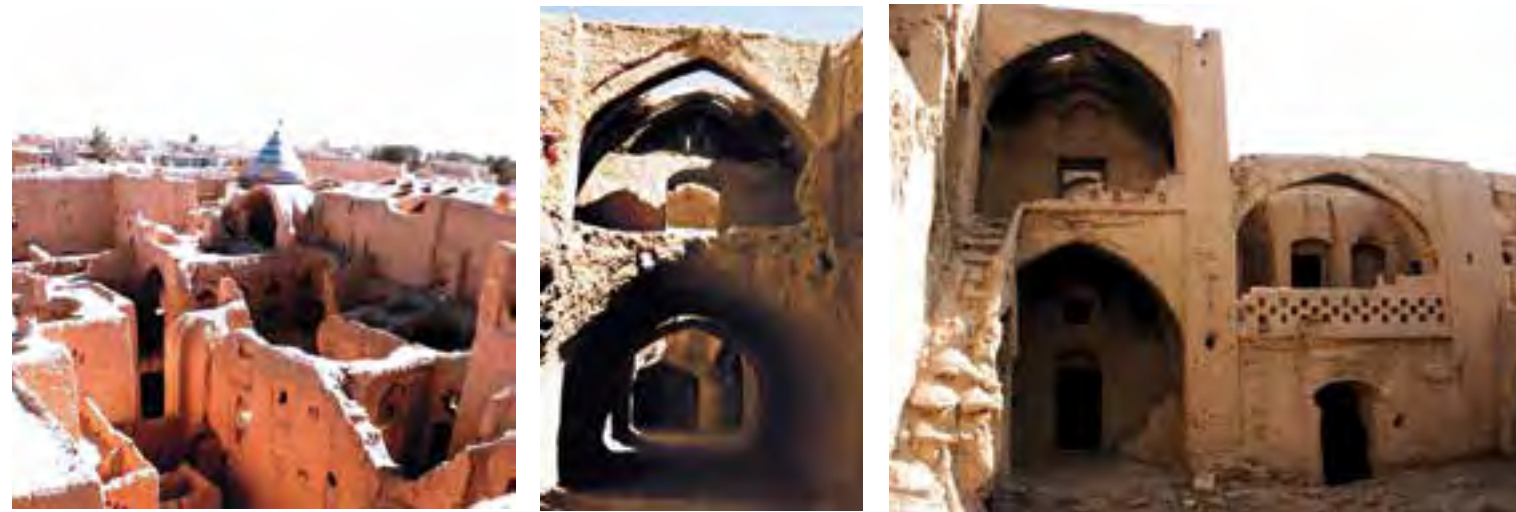
Fig.2, Fig.3 and Fig.4 Historical structures in Moorcheh Khort, Iran (credits: M. R. Manouchehri, 2008)

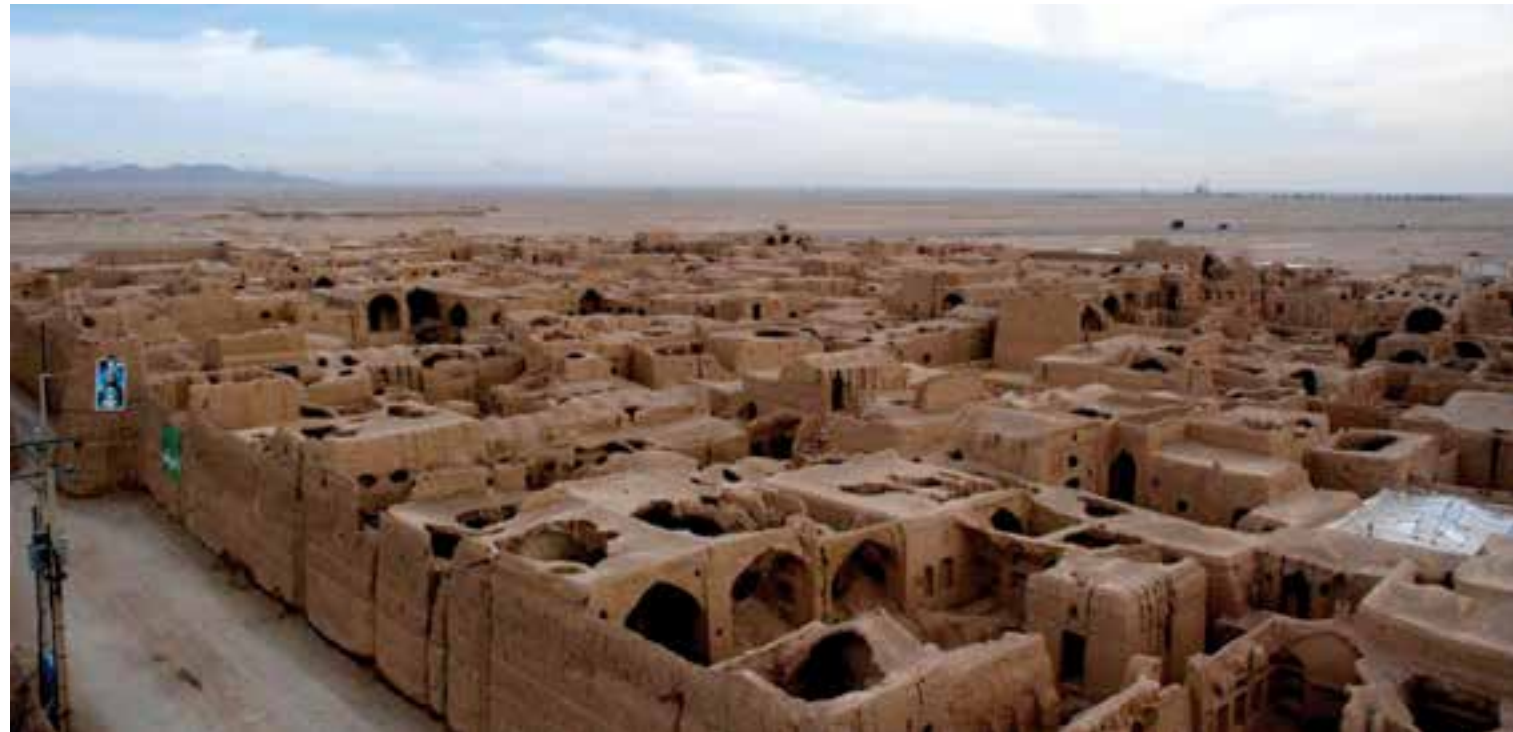
Fig.5 General view from above the historic fortress (credits: M.R. Manouchehri, 2008)

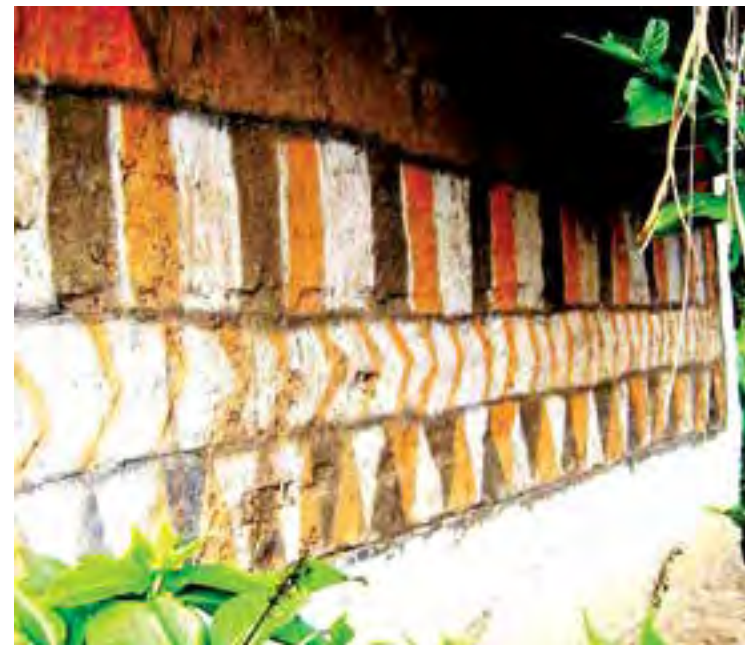
Fig.6 Strip-pattern semiotics at Bugiri Uganda (credits: Allan Birabi, 2010)

Within the earthen-architectural wall-semiotics context, the illustration below is one among numerous other exemplars traced on a house at Bugiri, Eastern Uganda. With a powerful intuitive sense of fractal ethnomathematics arranged with meticulous strip patterns, repetition is by means of combined vertical, horizontal, or glide reflections. Glide reflections are the result of the artisan maneuvering a fractal or unit of design in one direction for a definite amount of distance. This process is then repeated to cover the predetermined wall area.

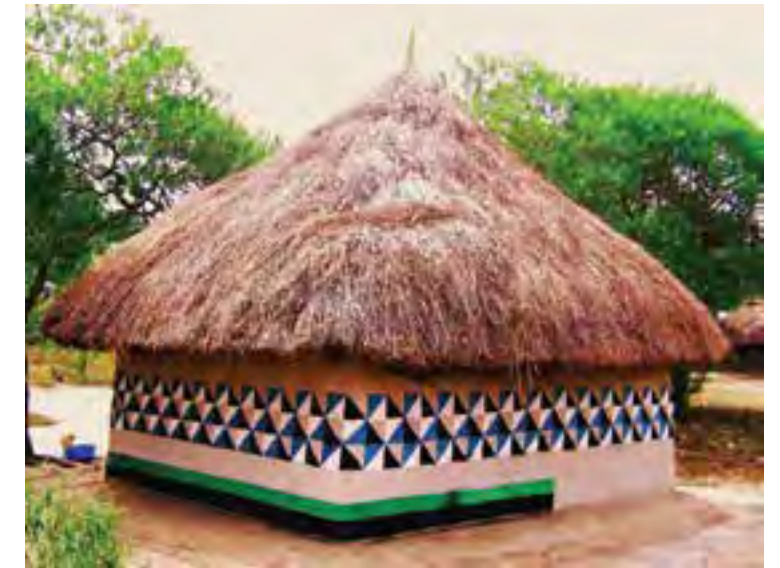
Fig.8 Earthen-wall tessellation semiotics at Magodes, Molo, Tororo District, Uganda (credits: Allan Birabi, 2010)

Another stylish exemplar of Ugandan earthen ethnomathematical-wall semiotics was reviewed at Magodes in Tororo District. With sophisticated tessellation geometry, coupled with design elements of line, color, dramatic contrast, and organizational ethnomathematics, the artisan registers a commendable degree of superb interplay of mixed color pattern and textural charisma to turn the mere flat wall into a somewhat 'wise', energetic, musical, and educative surface.

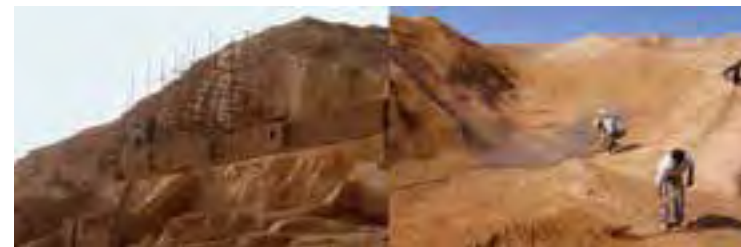
Fig.2 Surface protection and visual reintegration of the peak of Tchogha Zanbil Ziggurat by Kahgel (credits: The World Heritage of Tchogha Zanbil, 2004)

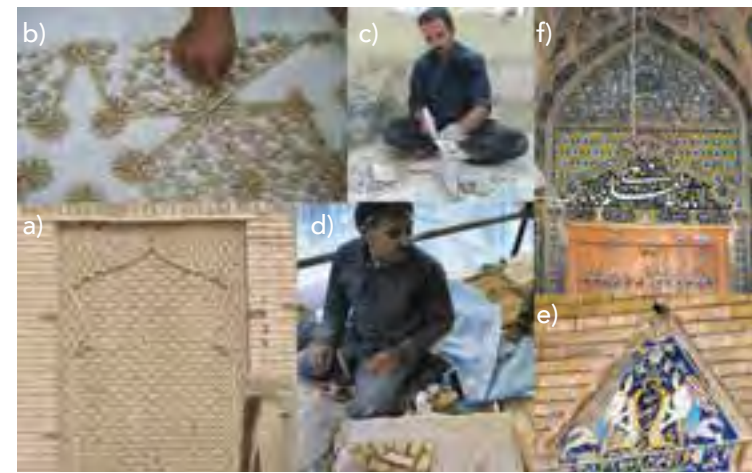
Fig.4 Examples of Moarraque, a method for surface protection of earthen architecture in Isfahan: a) brickwork in David's House; b), c) and d) design, cut and installation of mosaic pieces on earthen walls; diversity of approaches in the early 20th century in e) Sadr Madrasa and f) Harunieh alley (credits: Vahidzadeh et al., 2011)

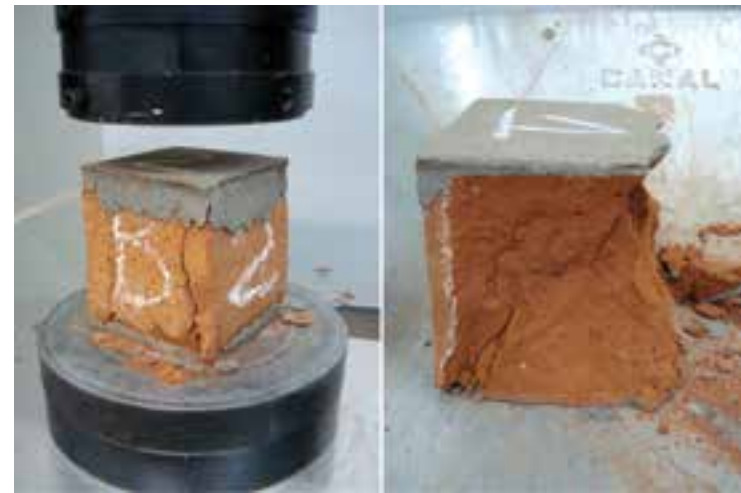
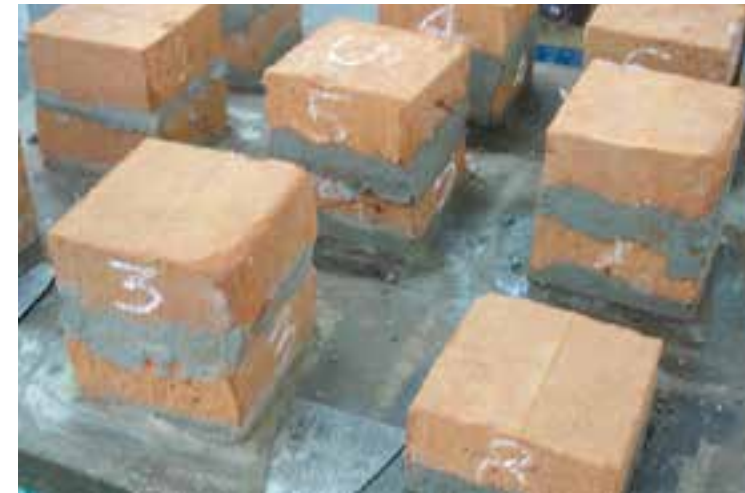
Fig.1 Samples: a) Cube; b) Cut adobe with the halves reunited (credits: Obede B. Faria, 2008)

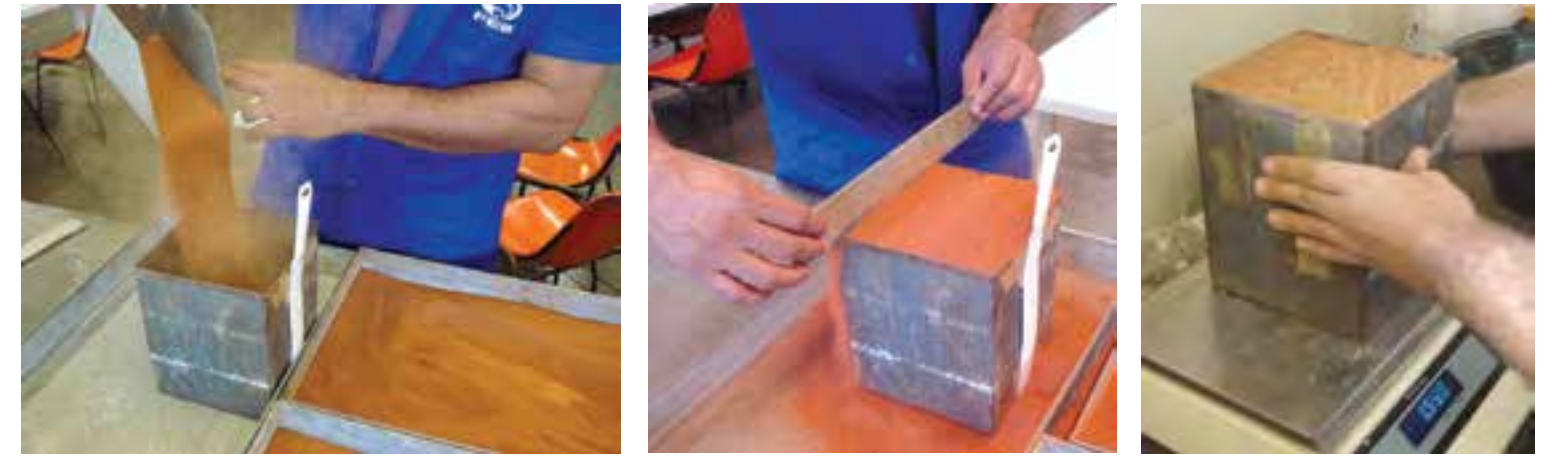
Fig.2 Determining loose soil density (credits: Obede B. Faria, 2008)

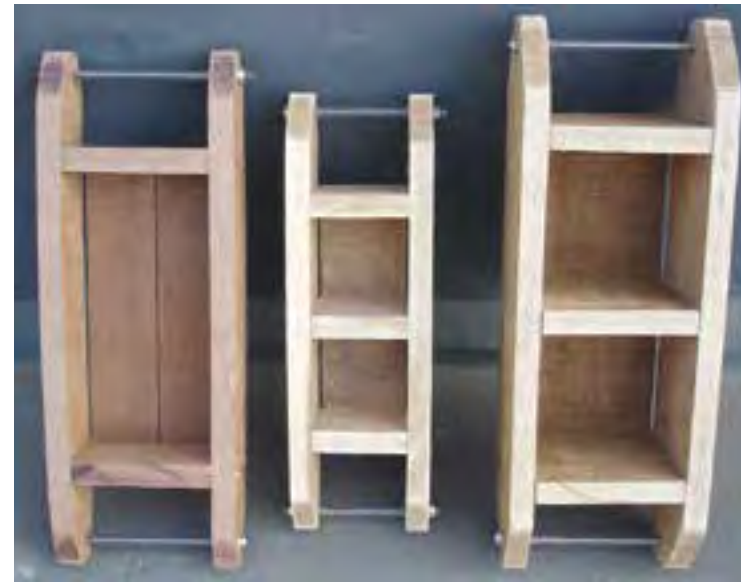
Fig.3 Molds for sample preparation (credits: Obede B. Faria, 2008)

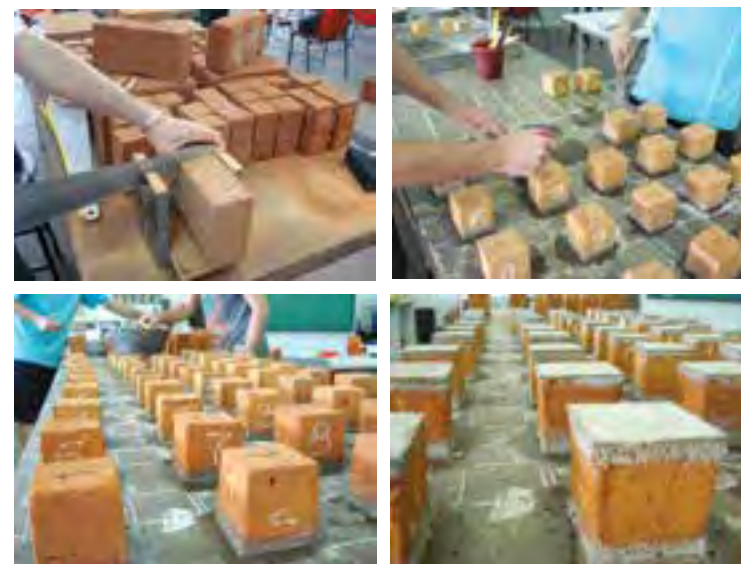
Fig.4 Some steps for the preparation of samples (credits: Obede B. Faria, 2008)

10 copies of each of the three samples, including Cube 7.5 (trimmed), Cube 10 and Cube 15 (both molded), were placed in an oven at 100°C for 24 hours, aiming at standardizing the moisture content of the samples manufactured in different regions and climatic conditions. After drying, the bulk density of the samples was obtained through the determination of the ratio of dry mass and volume. The samples underwent compressive tests, with a load of a voltage-increase rate of 0.29MPa/min. Data was recorded on sheets prepared for the automatic calculation of results, according to the methodology proposed by Faria et al. (2008).

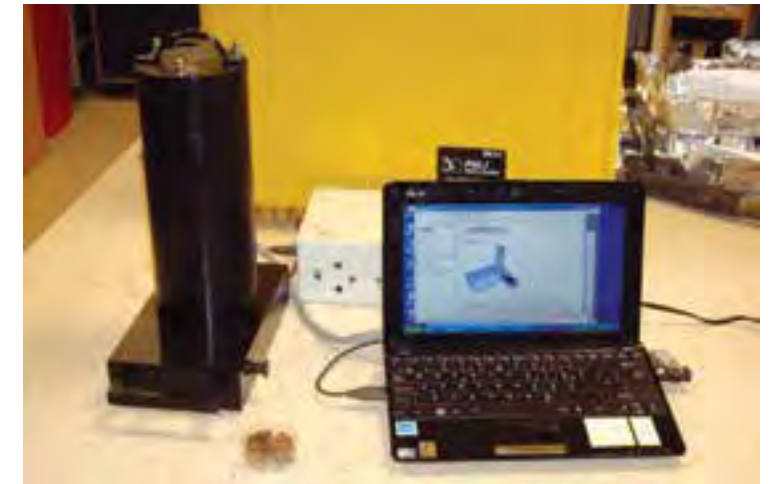
Fig.5 Portable luminescence-measurement apparatus comprising sample chamber with attached photomultiplier, control box, and laptop PC; sample in foreground (credits: Paul Adderley, 2012)

The SUERC portable luminescence-reader instrument was developed by Sanderson and Murphy (2010). It is designed to prioritize conventional dating measurements by allowing an assessment of mineralogical properties and sensitivities. It measures both infra-red (λ 880 nm) stimulated luminescence (IRSL) and blue-light (λ 470 nm) luminescence (OSL) stimulated luminescence. The greater the OSL count, the greater the age of sediment since last resetting by light or heat. Changes of the IRSL:OSL ratio are a possible proxy of mineralogical differences. To test the use of such an instrument for earthen-built structures, materials from an internal rammed-earth wall at Cottown Schoolhouse (Morton, 2011) and from the local clay source at Errol have been examined.

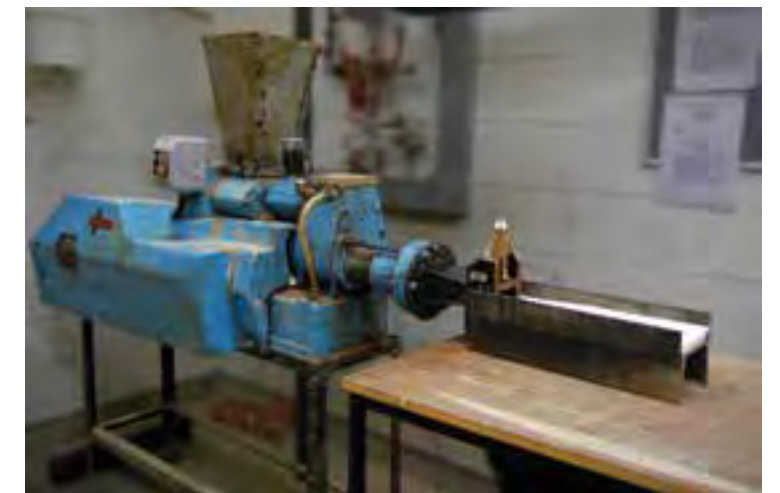
Fig.1 Laboratory vacuum pug-mill extruder (credits: Daniel Maskell)

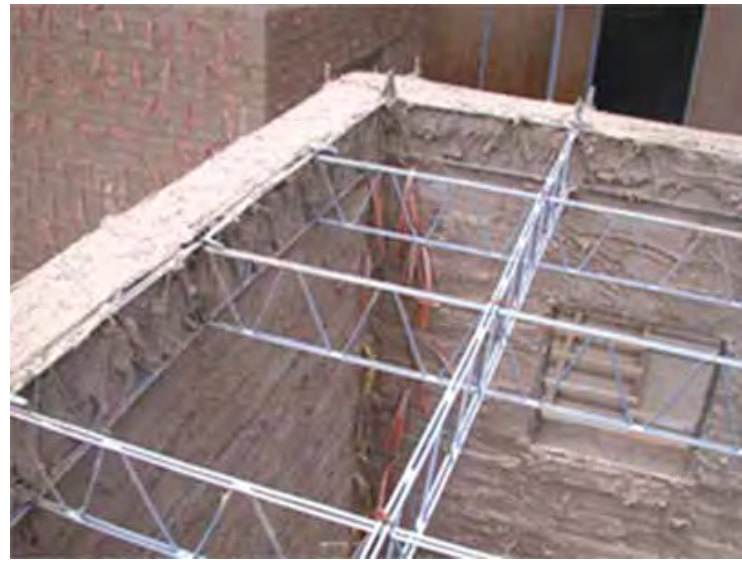
Fig.3 The unreinforced corner had no major complications. Note that the rack truss, which functions as the ceiling joists, also functions as a perimeter beam (credits: Adell, 2008)

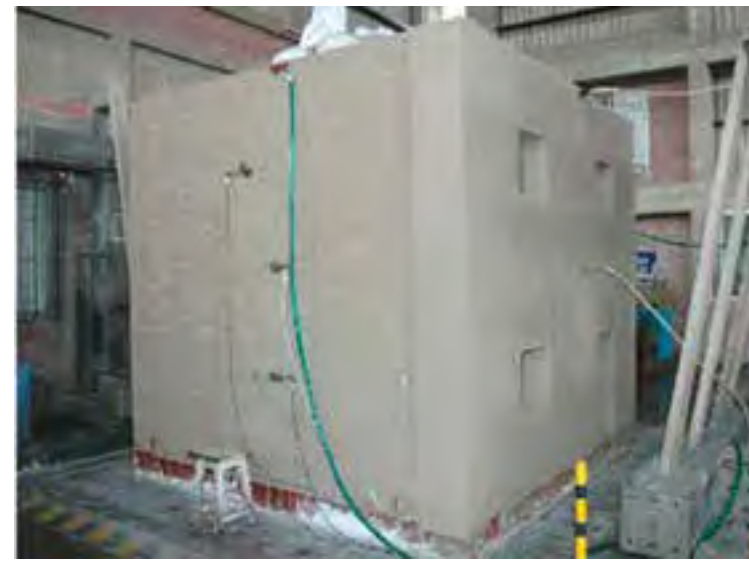
Fig.4 Prototype before Phase 1 testing (credits: Adell, 2008)

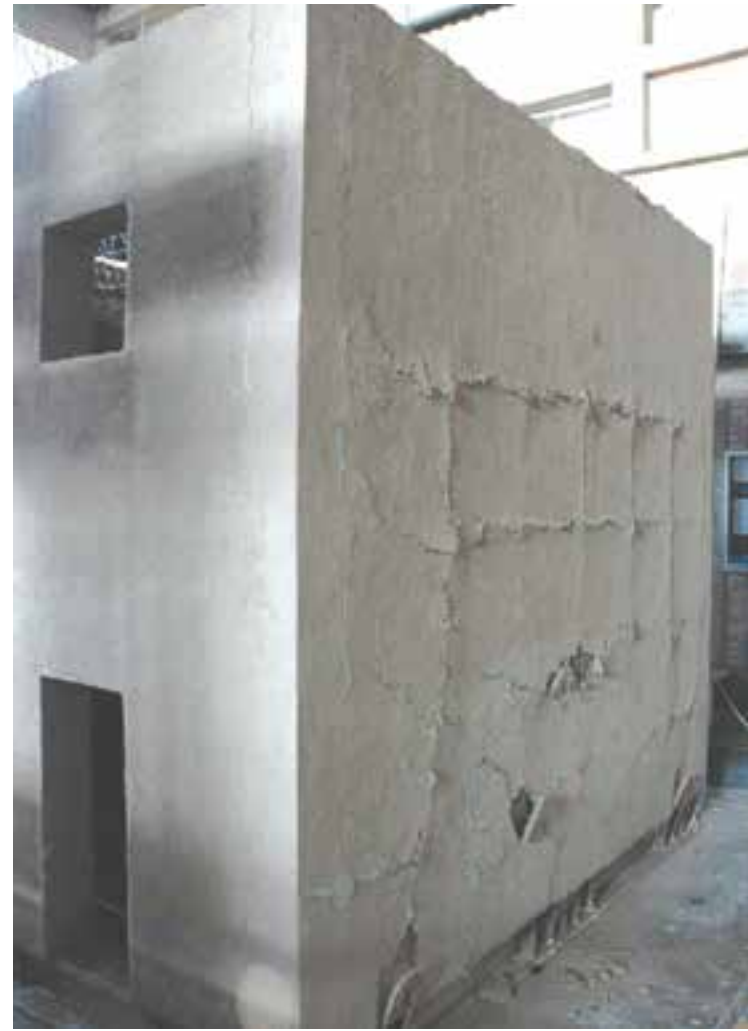
- **Post-Phase 4:** This was the last phase. The two trusses delimiting the doorway on the MP wall are deformed, as well as the one at the window opening of the first level. The elevations illustrate the location of cracks following the fourth phase (130mm). Notwithstanding, the prototype remained standing.

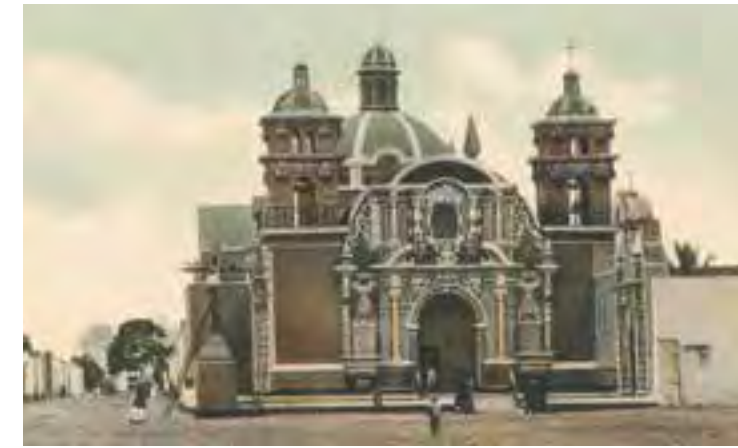
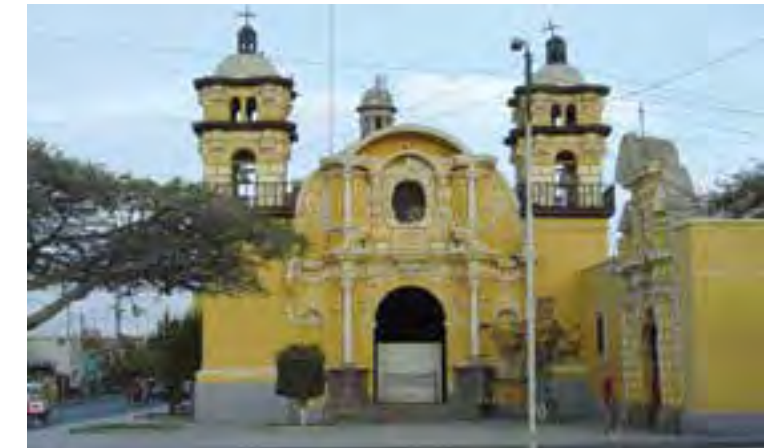
Fig.2 The *Compañía* Church, in Pisco: a) In 1920, the church had endured the great earthquakes of 1746 and 1877 without collapsing; b) By 2007, before the earthquake, the building had a cement floor, and the paved streets prevented earthen substrate from expelling vapor (credits: Domingo Canepa, 1920; Pedro Hurtado Valdez, 2007)

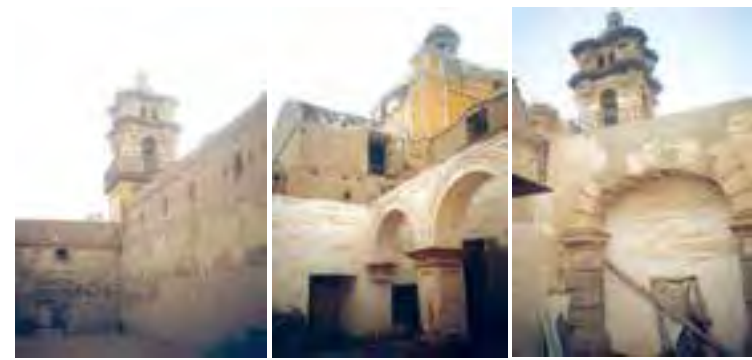
Fig.3 The *Compañía* Church, Pisco: a) Adobe walls coated with cement at the bottom; b) Earthen-framework vault and dome left weathering without an earthen coating; c) Adobe arch with cementitious-coating renovation (credits: Pedro Hurtado Valdez, 2007)

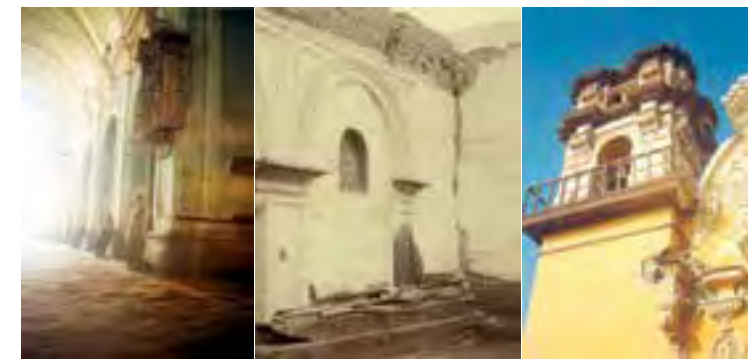
Fig.4 The *Compañía* Church, Pisco: a) Adobe walls with humidity and differential settlement; b) Adobe walls with loss of the original locking elements and the ties between themselves; c) Crack separating the walls of the tower and façade of the nave (credits: Pedro Hurtado Valdez, 2007)

The collapse of the earthen framework vault was due to factors related to the state of conservation of the structure. This was firstly motivated by the sharp deterioration of the walls on which the vaults were supported, which, during the earthquake, could not withstand the thrusts, overturning at the top and leaving the locking elements (*encadenado*) without support.

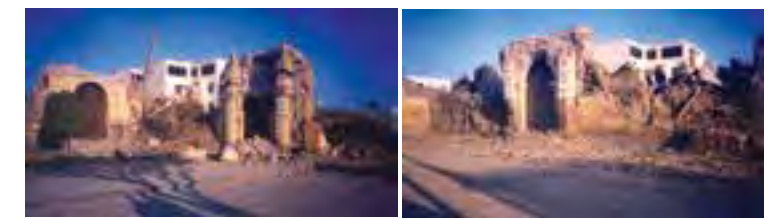
Fig.5 The *Compañía* Church, Pisco in 2007 after the earthquake: a) Area of the main façade and the entrance to the school, already separated from the rest of the wall pre-earthquake; b) Lateral façade also with separation cracks (credits: Pedro Hurtado Valdez, 2007)

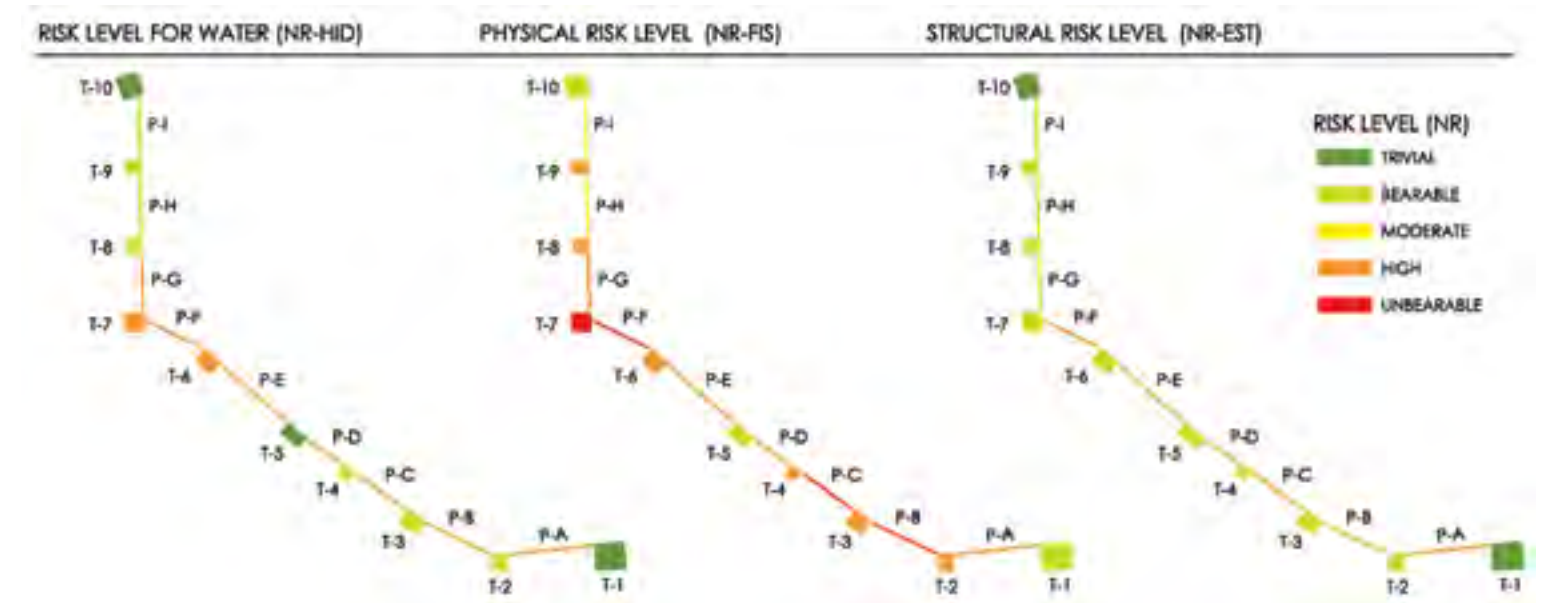
Fig.2 Distribution of the NR for the analyzed wall sections (T1 through T10) (credits: J. Canivell, 2011)

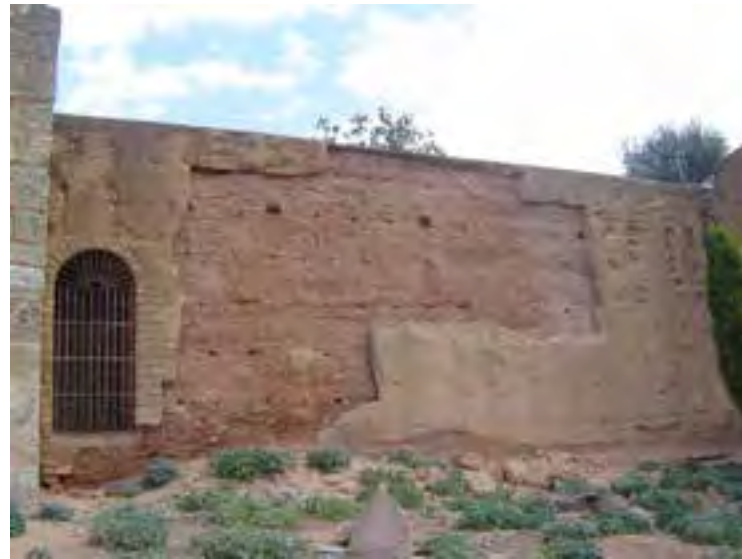
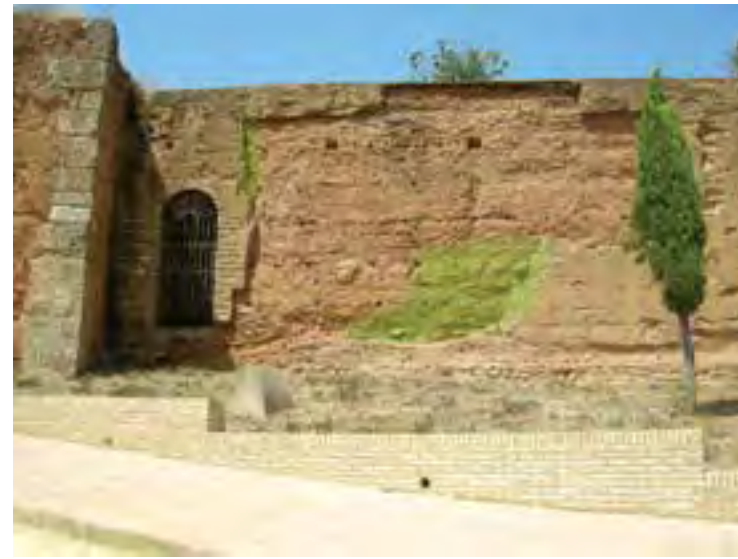
Fig.3 Damage in earthen the fabric of the wall between Towers 6 and 7 in 2009 (credits: A. González, 2009)
Fig.4 Damage in earthen the fabric of the wall between Towers 6 and 7 in 2011 (credits: J. Canivell, 2011)

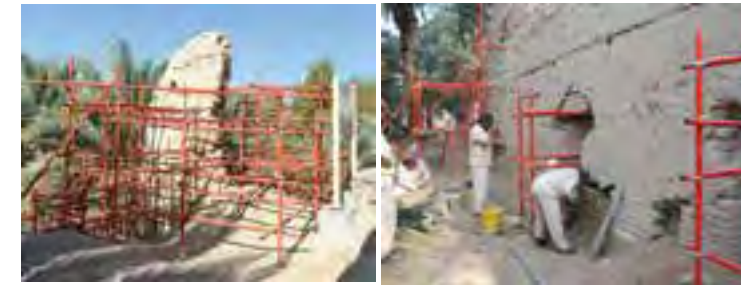
Fig.2 Al-Suroor Southern House after emergency stabilization (credits: Salman Muhammad © ADACH, 2011)

Fig.3 Repair of coving at Mohammed Bin Bidowah Al-Darmaki House (credits: Ali Malekabbasi © ADACH, 2010)

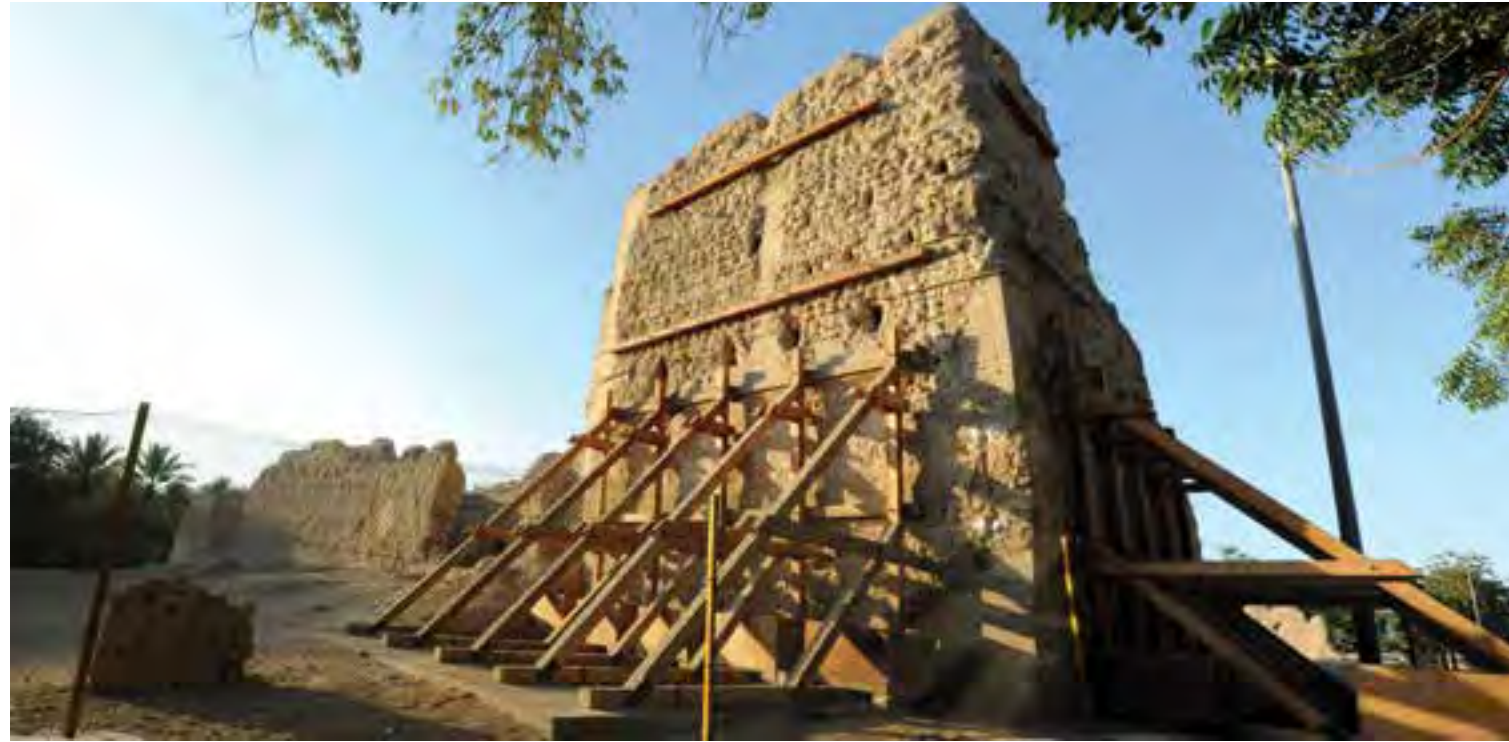
Fig.4 Abdullah Bin Salem Al-Darmaki House showing steel pinning and shoring (credits: Salman Muhammad © ADACH, 2011)

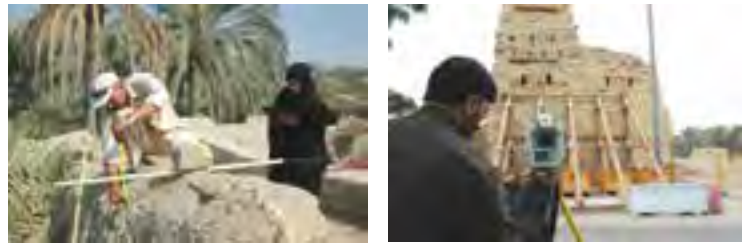
Fig.6 and fig.7 Documentation of Jimi Walls and monitoring of Abdullah Bin Salem Al Darmaki House (credits: Salman Muhammad © ADACH, 2010 - Ali Malekabbasi © ADACH, 2011)

The level of precision of documentation and monitoring is defined according to both significance and vulnerability. A regime for managing monitoring tasks across buildings guarantees control of possible deterioration and triggers appropriate actions in good timing.
