TERRA 2012 | 12th SIACOT PROCEEDINGS

11th International Conference on the Study and Conservation
of Earthen Architectural Heritage

12th SIACOT Iberian-American Seminar on Earthen
Architecture and Construction

Edited by
Mariana Correia, Pamela Jerome
Marcial Bondet, Maddalena Achenza

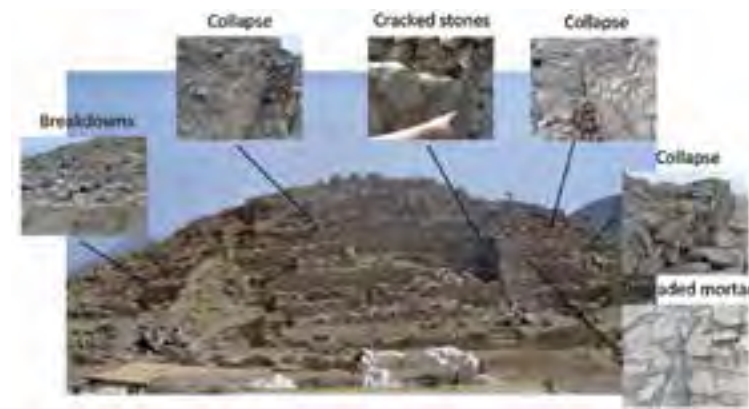
Fig.1 La Galería Stepped Pyramid, Caral, Peru, constructed of stone and earth around 2700 BCE. Signs of deterioration (credits: J. Vargas, C. Iwaki, A. Rubiños)

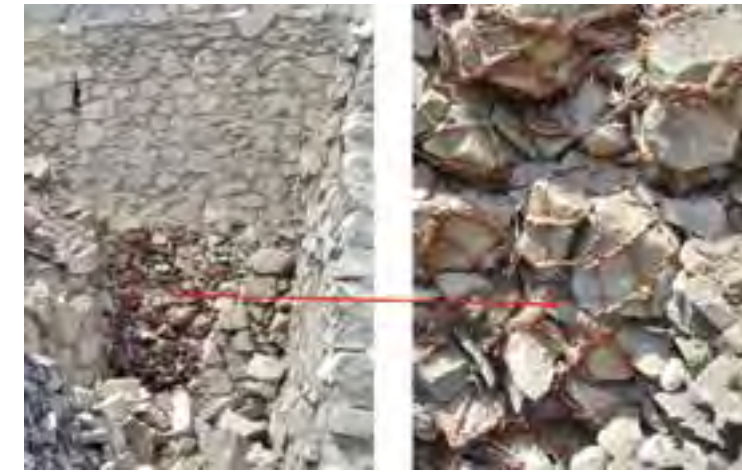
Fig.2 Reed *shicras* providing stability to the fill. There are fills with balanced vertical flat edges, which supported the upper overburden and the expansion of the *shicras'* area (credits: J. Vargas-Neumann)

These bags of vegetable fiber (junco, white grass, etc.) contained a volume of stone and were called *shicras*. These are a constructive element, that is a very advanced concept for its time, which could be efficiently used in modern times for slope stability and control of landslides. The volumes of the *shicras* found can weigh between 15 kgf to 2,000 kgf. The result of their use was the successful construction of assembled piles of mounds or stable pyramids, with optimal earthquake resistant features. The pattern of *shicras* fill was determined. These differ in their disposition, quantity and their interaction with other materials, such as gravel and large stones.

The main reinforcement elements of the structural nuclei were the *shicras*. These controlled deformations and displacements similar to contemporary gabions. However, the *shicras* have undergone a process of deterioration that has caused the loss of their primal structural characteristics. Earthquakes of later centuries tore down the walls and exposed the *shicras* to weather and ultraviolet rays, reducing their durability and resistance. Even so, the *shicras* and the *quincha* walls are reliable and a robust development of earthquake resistant knowledge at Caral and in the surrounding Supe Valley.

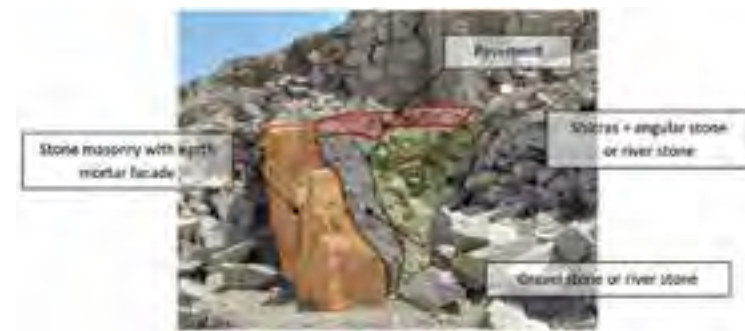
Fig.3 The first type of nucleus structure in La Galería pyramid (credits: J. Vargas-Neumann)

The structural feature of the nuclei caused the walls or the façades not to have a significant structural function. Their purpose was to provide a surface for plastered or painted decorative features, and to define the building. The nuclei withstood earthquakes and the pyramids were stable. The walls were vulnerable, but their collapse did not affect the overall stability of the pyramids.

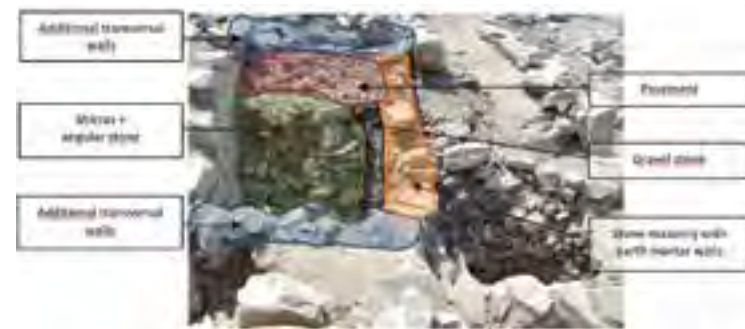
Fig.4 Alternative to the first type of nucleus structure (credits: J. Vargas-Neumann)

large stones with no mortar, which separated the shicras core and the angular gravel fill. For practical reasons on very long walls, the angular gravel fill, glued to the wall façade, was also bagged in *shicras*. These were, possibly, reconstructions situations, where the facing is remade into a new position to the outside.

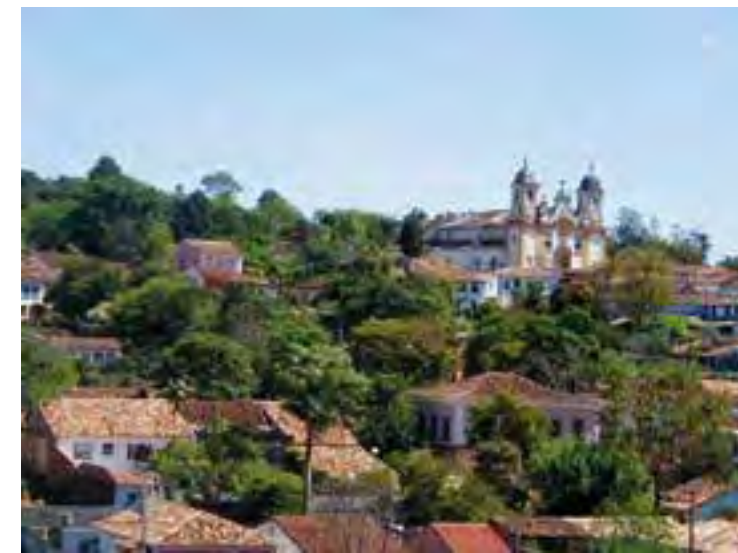
Fig.1 City of Tiradentes, Minas Gerais in Brazil; on the top right is the Igreja Matriz de Santo Antonio (credits: IPHAN Archive)

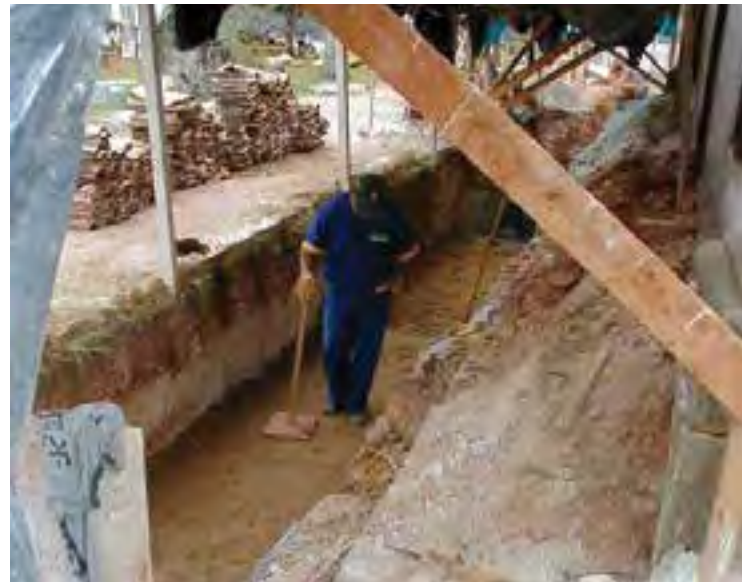
Fig.2 Rammed-earth veneer to protect the foundations of the Igreja Matriz De Santo Antonio (credits: Silvia Puccioni, 2000)

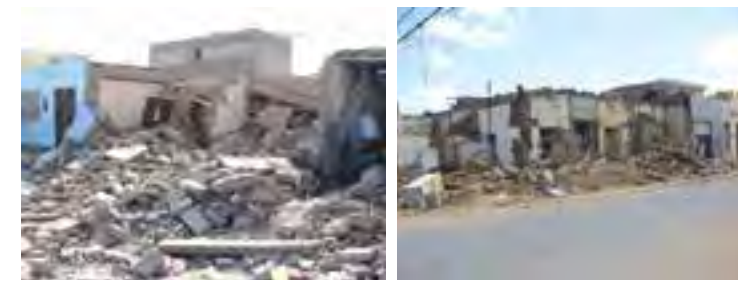
Fig.1 Collapsed houses during the earthquakes of Pisco, Peru, 2007 and Maule, Chile, 2010 (credits: J. Vargas-Neumann, 2007 y 2010)

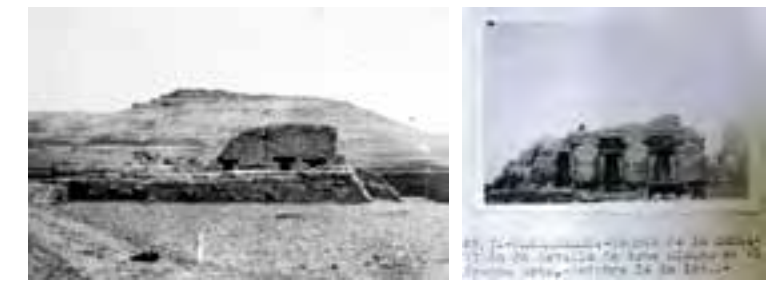
Fig.2 a) Ruins of the Temples of the Moon and Sun (back); and b) Detail (credits: Archive J.C. Tello, 1940)

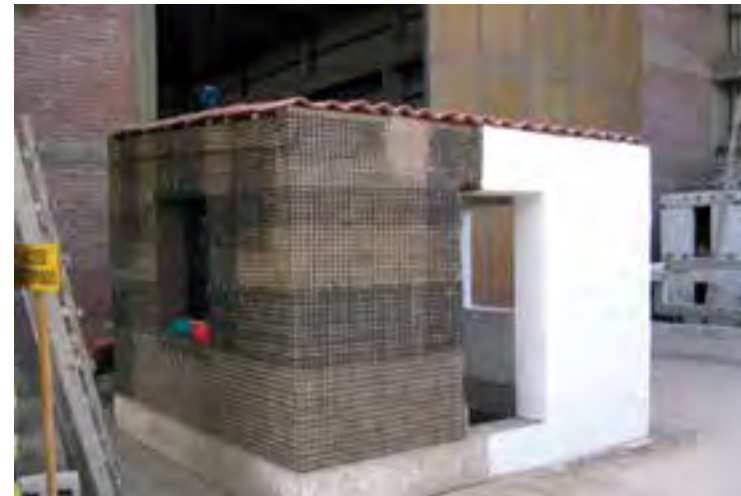
Fig.4 Module reinforced with synthetic mesh or geogrid with total reinforcement and coating of half of the module (credits: File PUCP, 2007)

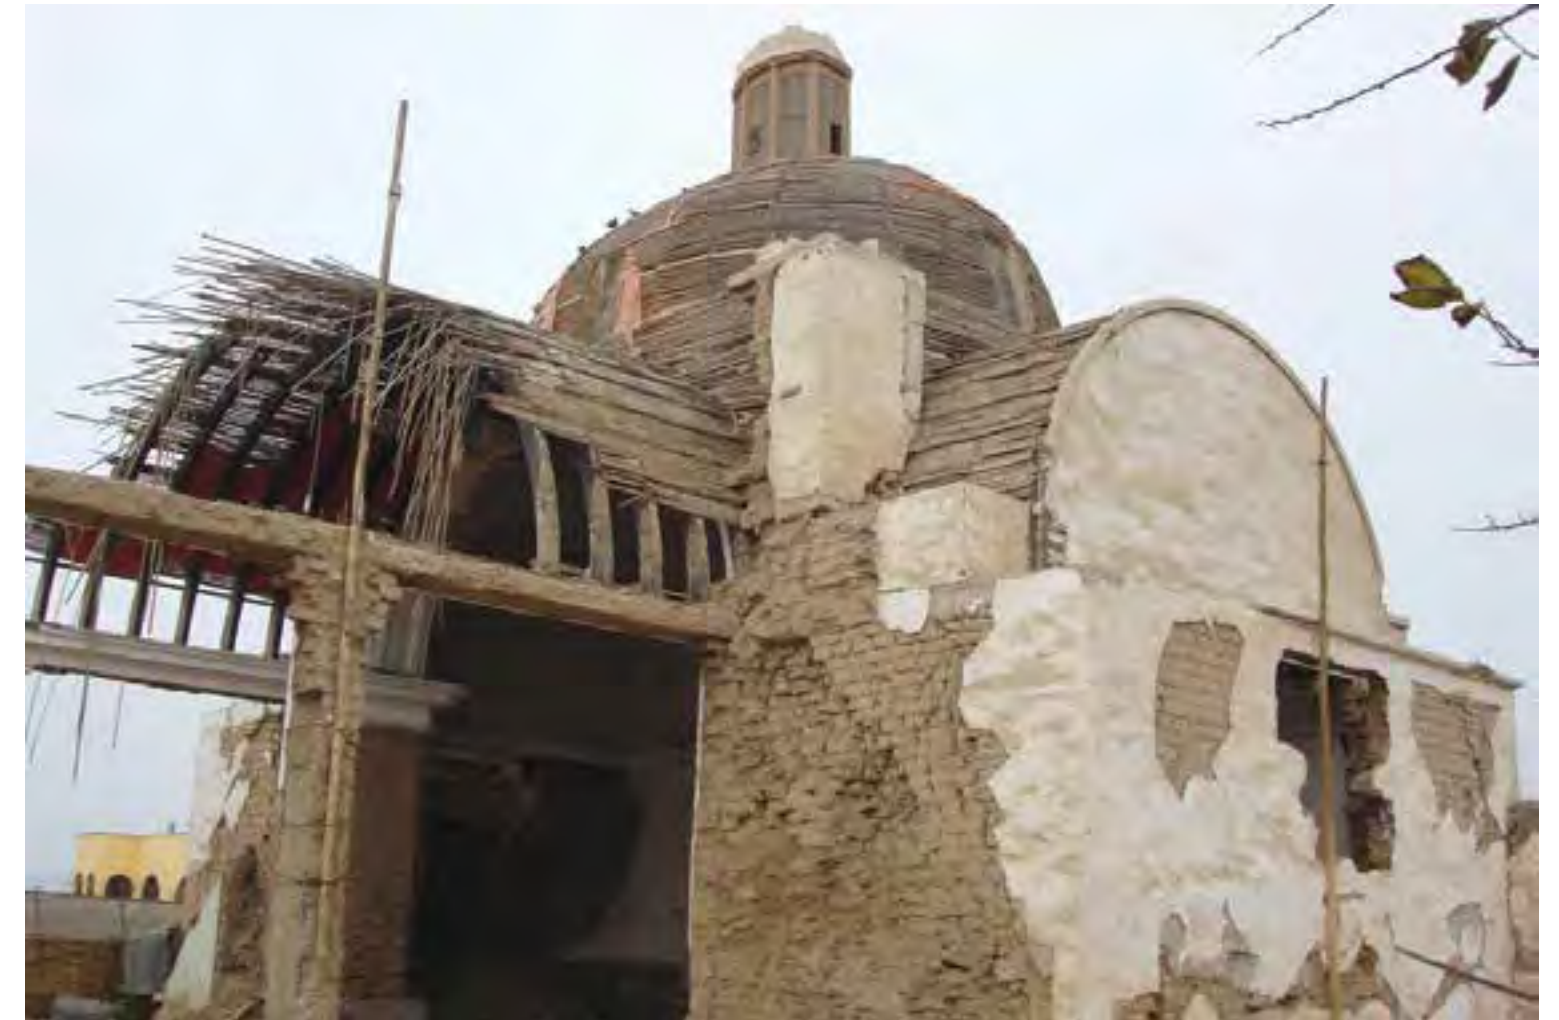
Fig.5 Avoid strengthening with reinforced concrete beams and columns, because they aid in collapse instead of protecting adobe walls, as in this example of the church of San Luis de Canete, damaged during the Pisco earthquake in 2007 (credits: J. Vargas-Neumann, 2007)

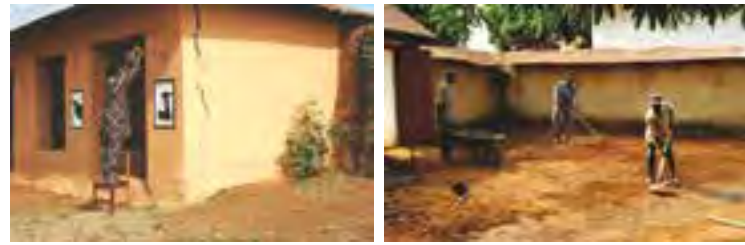
Fig.1 and fig.2 Preventive measures at the Royal Palaces of Abomey, 1996, Prema Project, ICCROM, CRAterre, DPC Benin (credits: Thierry Joffroy, 1996)

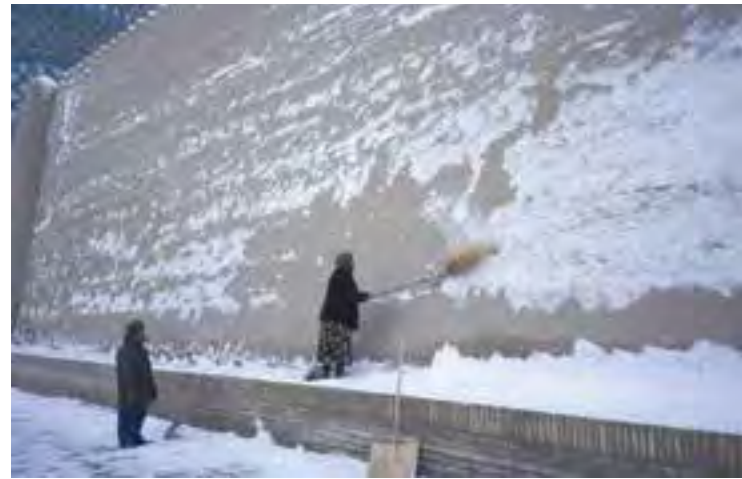
Fig.4 Traditional preventive measure of snow removal from a wall and wall base in Khiva, Uzbekistan (credits: Thierry Joffroy, 2003)

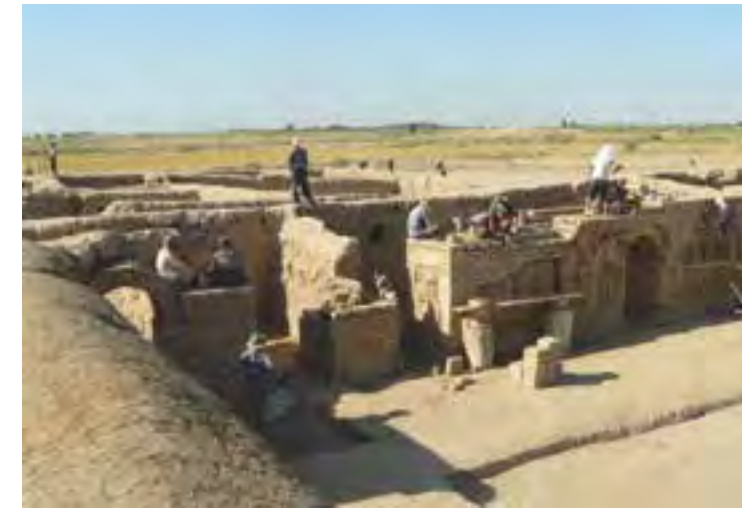
Fig.5 Test walls at Loropeni, Burkina Faso, WMF project (credits: David Gandreau, 2004)

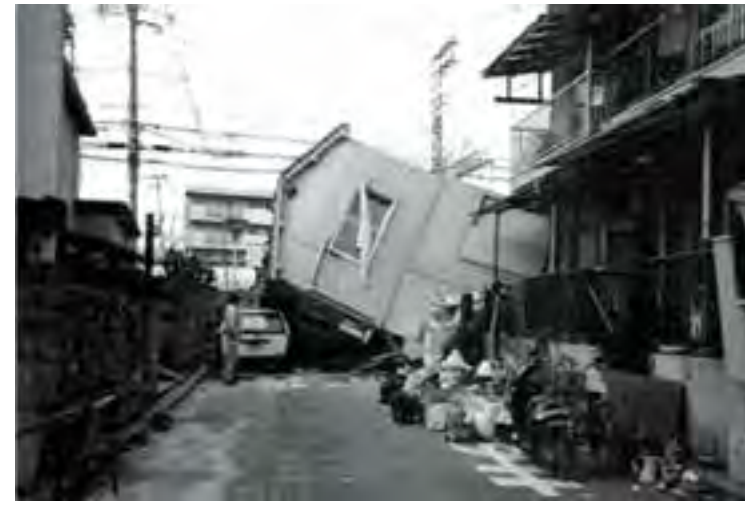
Fig.3 Kobe 15th Mansion (protected heritage) destroyed by Kobe Earthquake, M.7.3, January 17, 1995 caused liquefaction of the ground (credits: K.Masuda 1995)

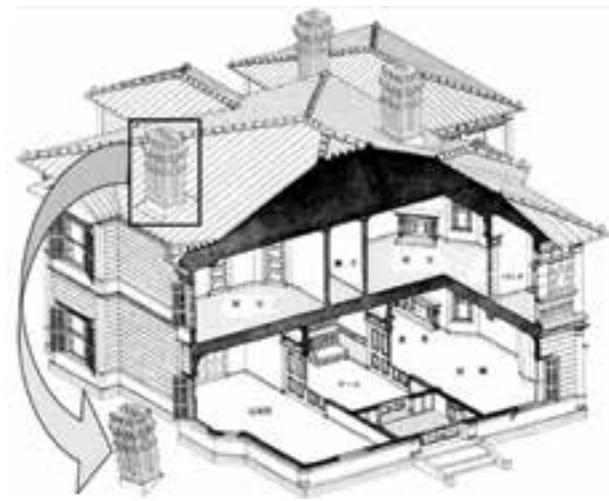
a) The Former Hunter House (A), 1903 and its fallen chimney in the garden.

Fig.5 Earthquake Damage and Reconstruction of Kobe 15th Mansion (credits: Masuda & Mendonza Shimada, edited from the Conservation Reports of Kobe Kitano District)

These houses were built before the 1920s, when brick structures became forbidden in Japan. The free-standing upper part of the chimney on the roof, with a weight of almost 1 ton, is considered a dangerous structure for earthquakes, when most of them are shaken, then fall down, destroying the roof, ceilings and floors all the way to the ground, making big holes at every level. Several brick chimneys came down beside the bed where house owners were sleeping, like a kind of air bombing.

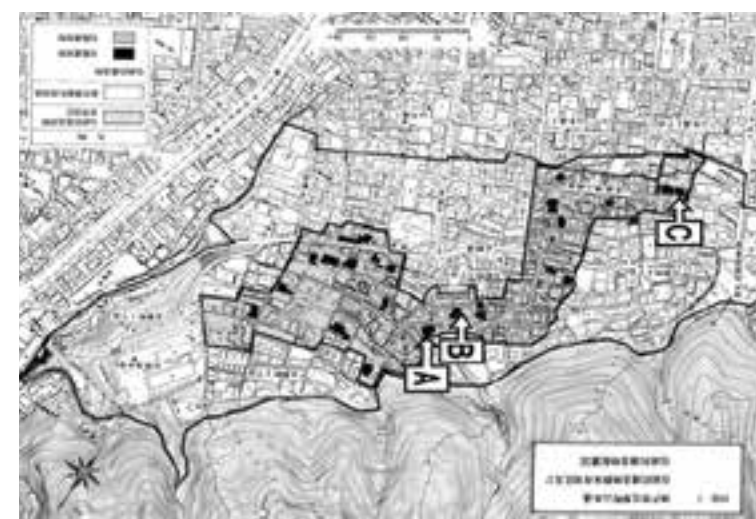
c) The Kobe-townscape conservation district, with many Western-style rich houses, was also damaged by Kobe Earthquake 1995.

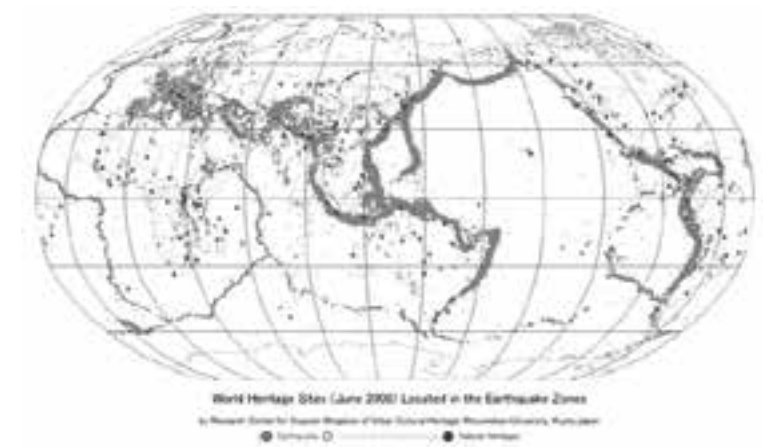
Fig.6 Map of UNESCO World Heritage sites located in earthquake zones (credits: UNESCO-WHC)

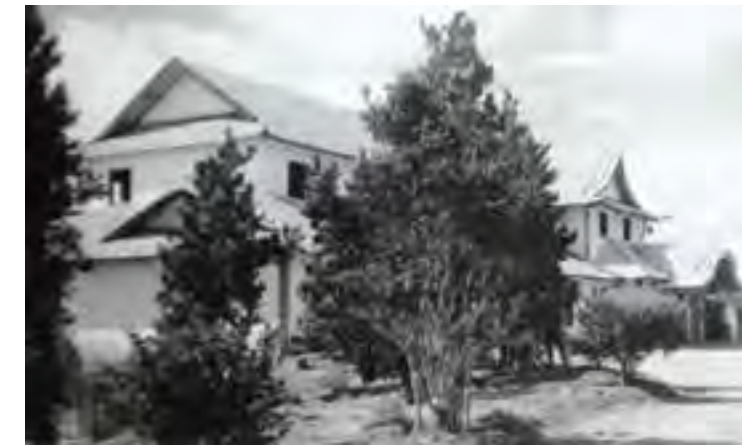
Fig.1 *Casarão do Chá*, Mogi das Cruzes, Brazil (credits: Eduardo Gamboa, 2007)

Casarão do Chá was built on two levels; the plan of the first floor was 35.50 m x 15.40 m, enclosing an area of 547.70 m²; and the second floor with its pink mahogany flooring had an area of 250.00 m². The upper floor was intended for the wilting of tea leaves, which was the first stage of the manufacturing process. Long net-

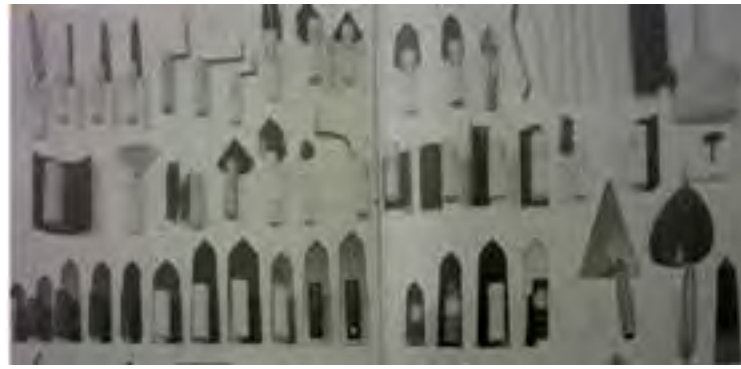
Fig.3 Llanas, trowels and other tools for building a wall (credits: Yamada, 2007)

Several tools were designed during the evolution of the Japanese technique, especially in the Middle Ages. In turn, experience with various materials developed based on earth, straw and other plant fibers, such as mitsumata (10) and the asa (11), as well as the use of resins from marine algae, virgin lime, and the combination of these elements in varied dosages, due to the peculiarities of each region.

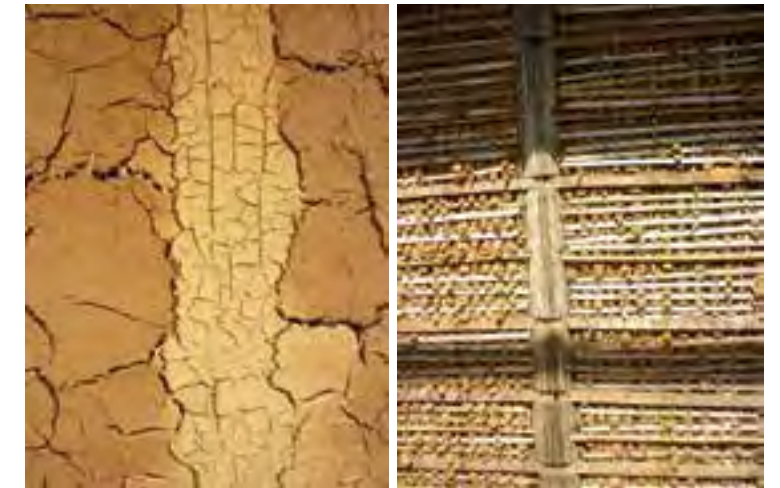
a) Shrinkage fissures resulting from drying of the first earthen layer; Fig.4a) b) Appearance of the inboard side (credits: Akemi Hijioka, 2010)
